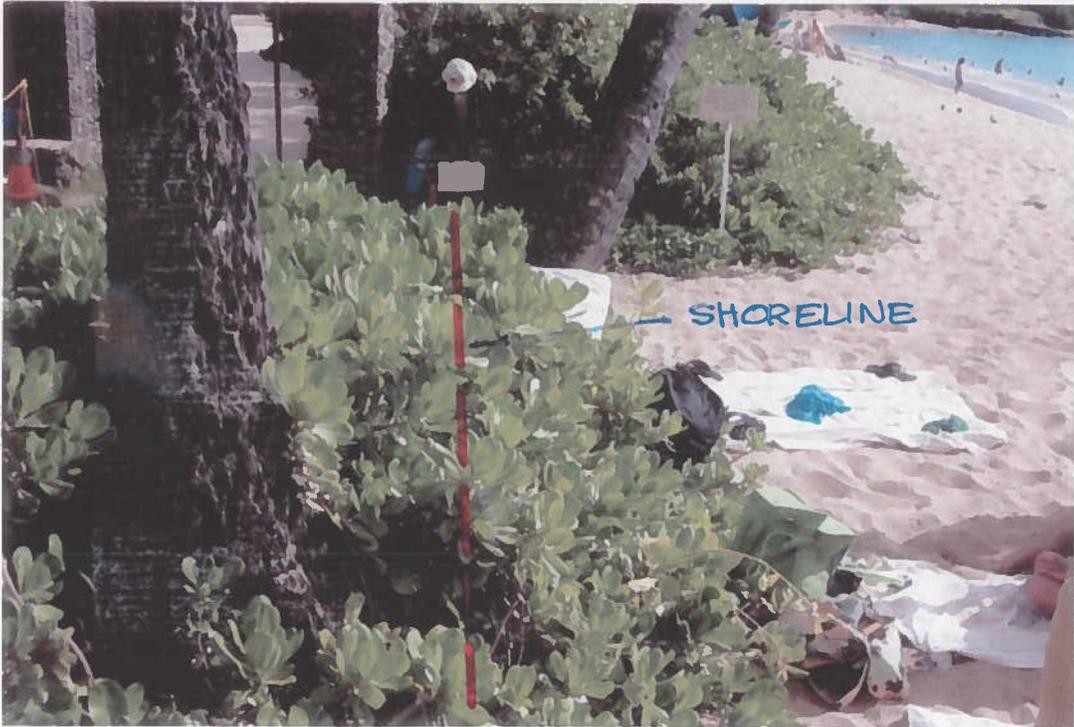
Photo # 1. Taken on 8/27/13 at southwest corner of Lot 47-A looking southward. Shoreline follows the upper reaches of waves at normal condition.

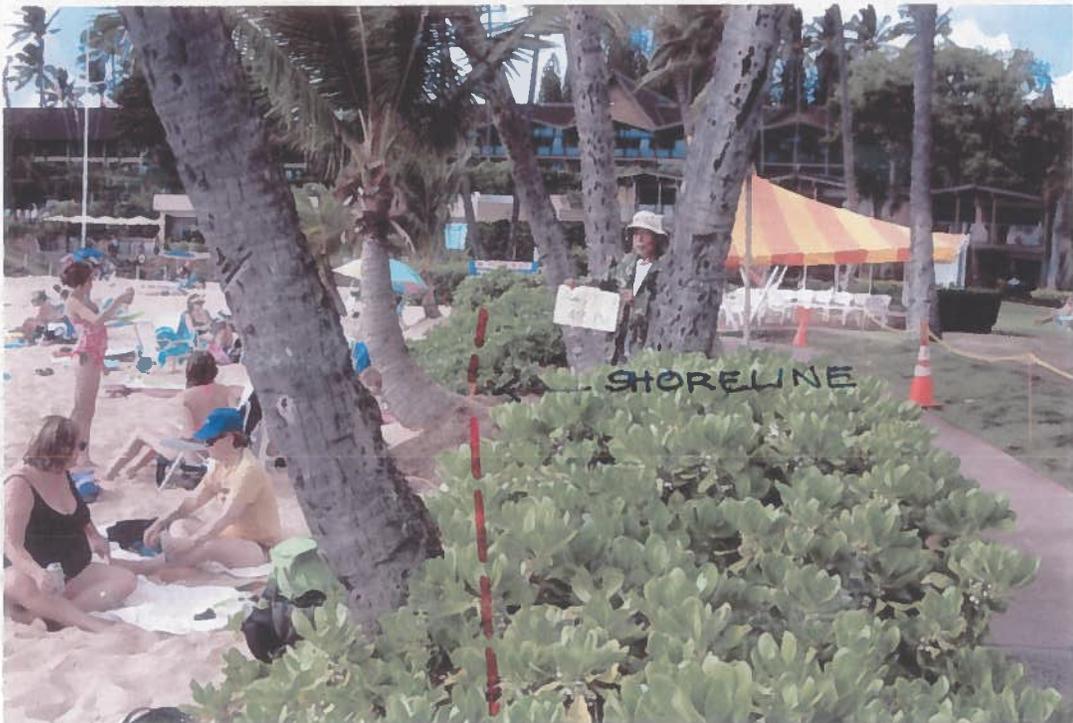
Photo # 2. Taken on 8/27/13 at southwest corner of Lot 47-A looking northward. Shoreline follows the upper reaches of waves at normal condition.

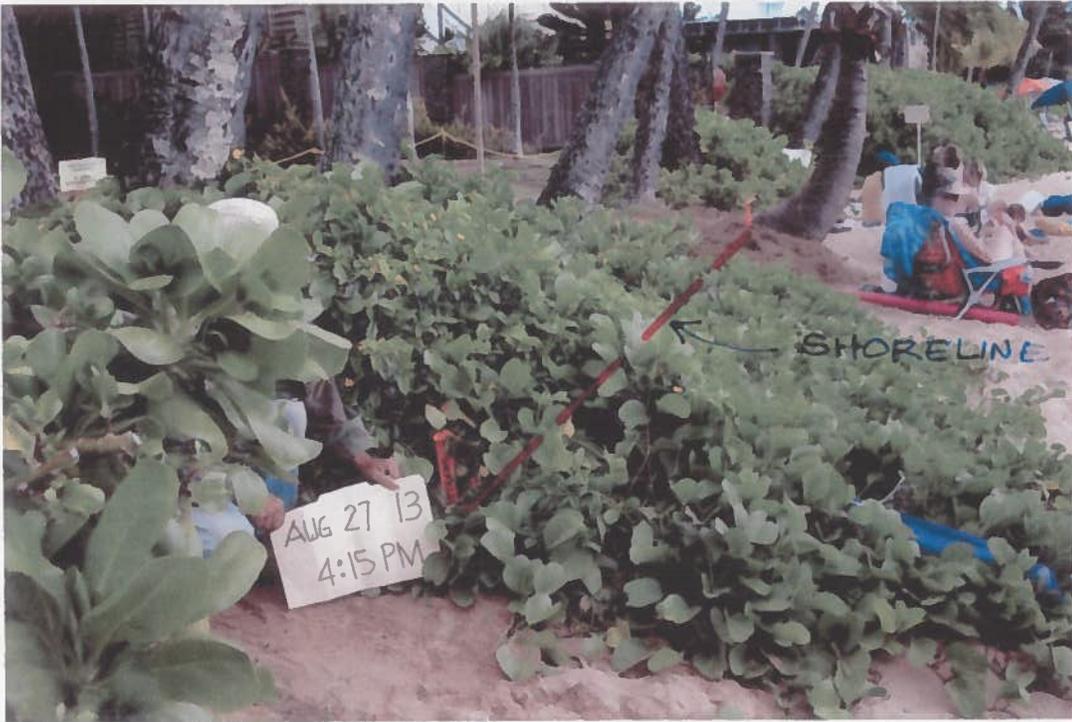
Photo # 3. Taken on 8/27/13 at southwest corner of Lot 47-A looking southward. Shoreline follows the upper reaches of wave at normal condition.

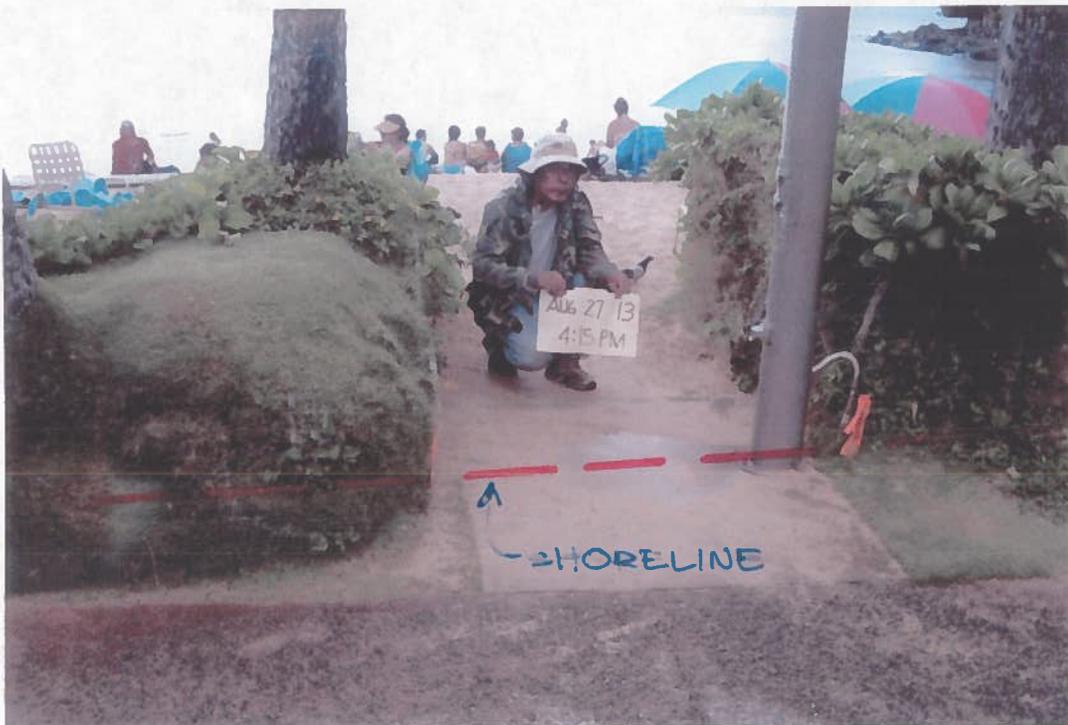
Photo # 4. Taken at mid section of Lot 47-A looking eastward. Shoreline follows the upper reaches of waves at normal condition

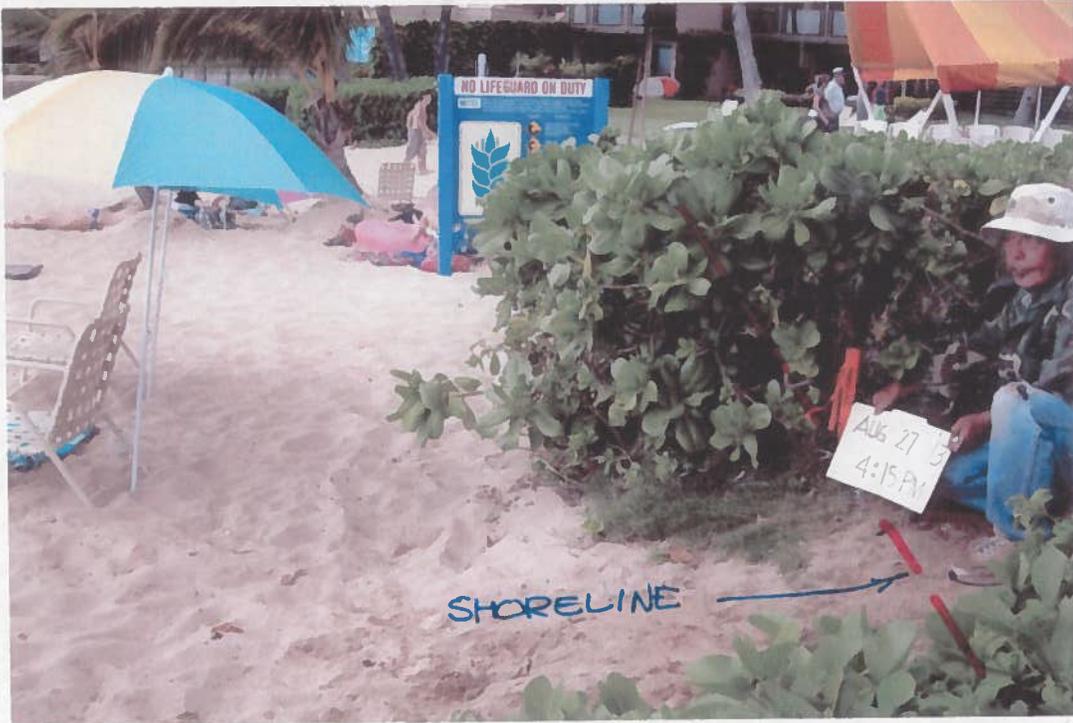
Photo # 5. Taken on 8/27/13 at mid section of Lot 47-A looking northward. Shoreline follows the upper reaches of waves at normal condition.

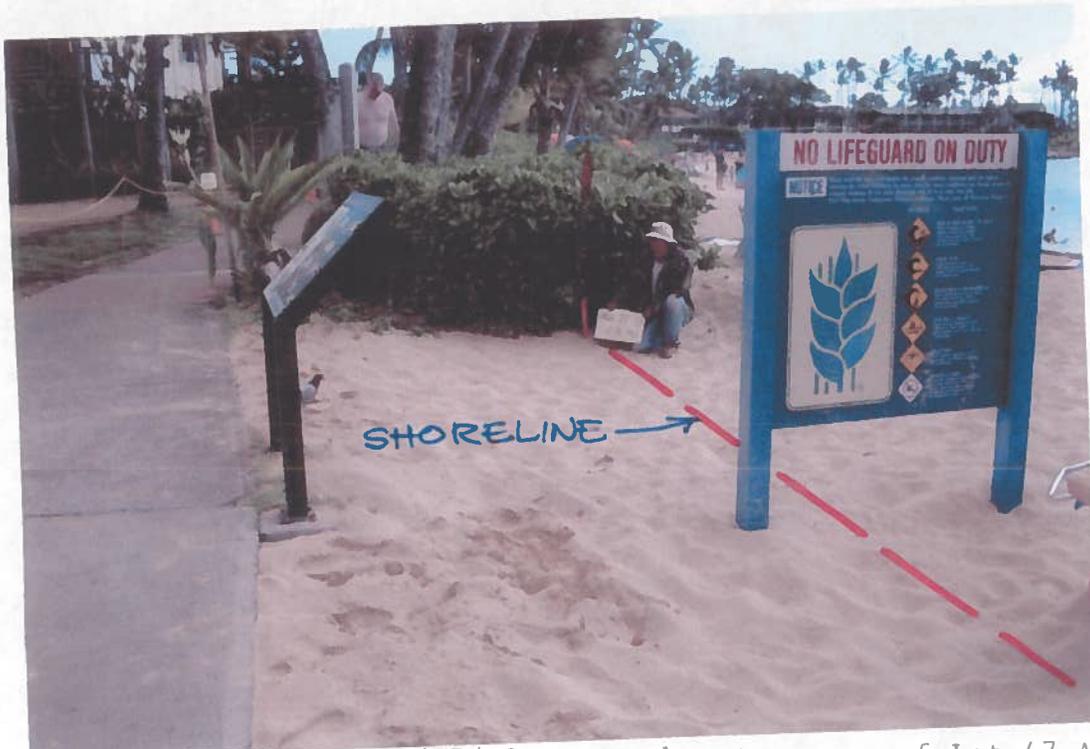
Photo # 6. Taken on 8/27/13 at northwest corner of Lot 47-A looking southward. Shoreline follows the upper reaches of waves at normal condition.

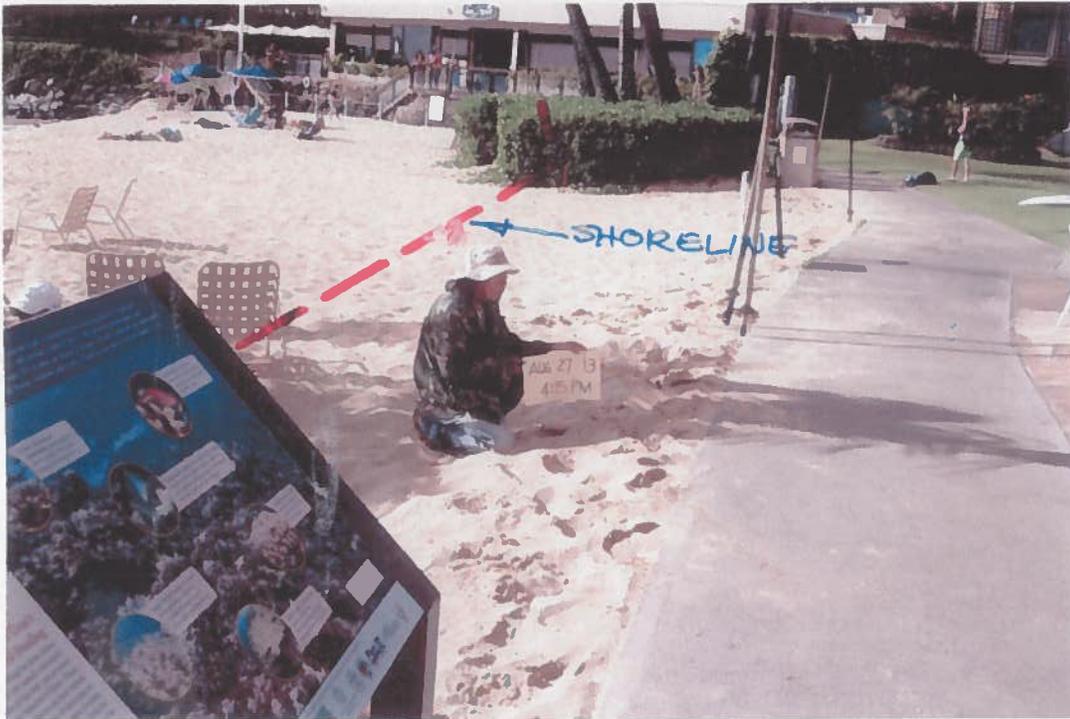
Photo # 7. Taken on 8/27/13 at northwest corner of Lot 47-A looking northward. Shoreline follows the upper reaches of waves at normal condition.

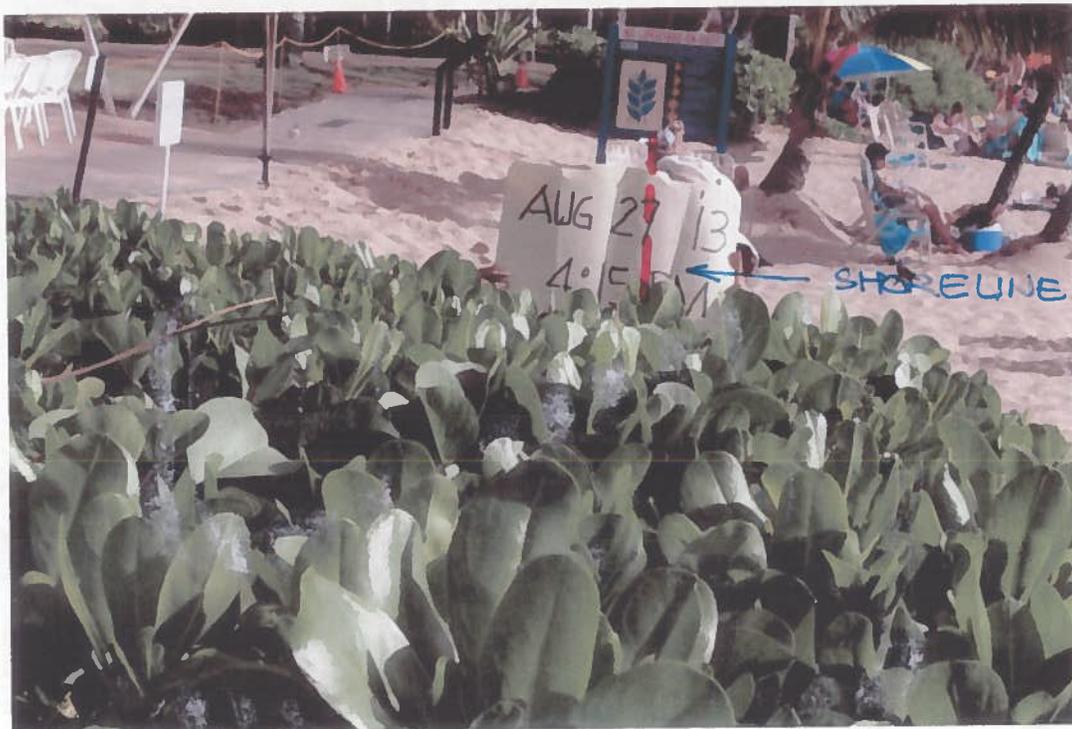
Photo # 8. Taken on 8/27/13 at northwest corner of Lot 47-A looking southward. Shoreline follows the upper reaches of waves at normal condition.

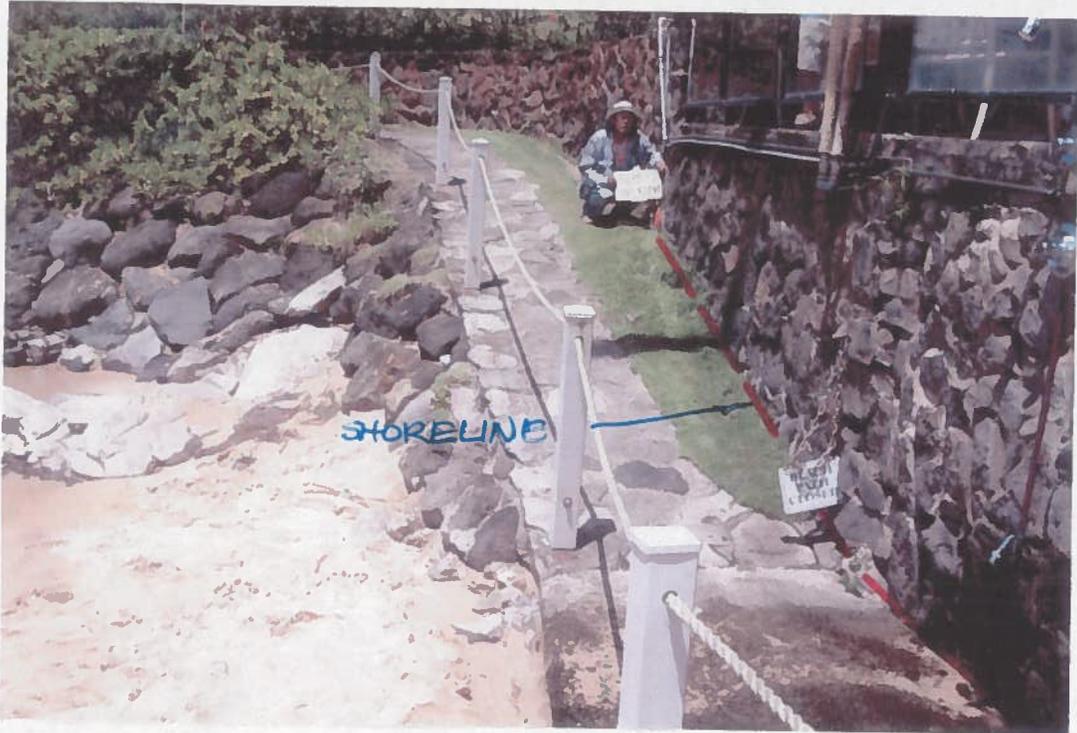
Photo # A Taken 9/17/13 at Northwest of property looking northwestward. Shoreline follows the toe of CRM wall.

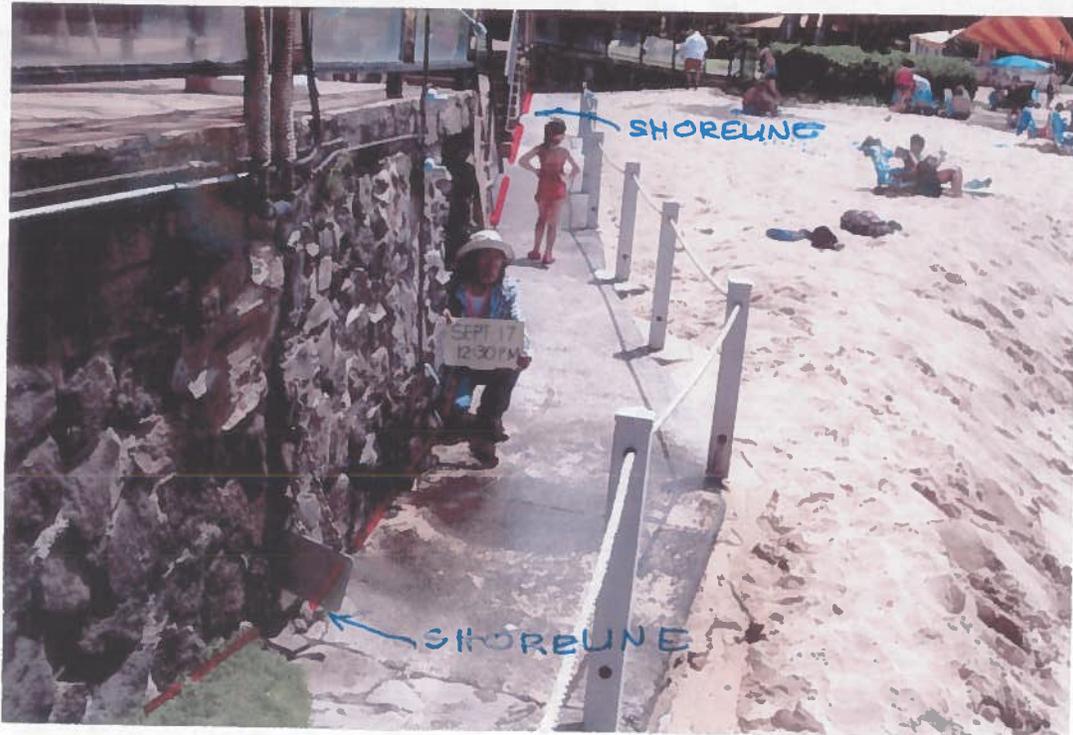
Photo # B. Taken 9/17/13 at northwest corner of property looking eastward. Shoreline follows the toe of CRM wall.

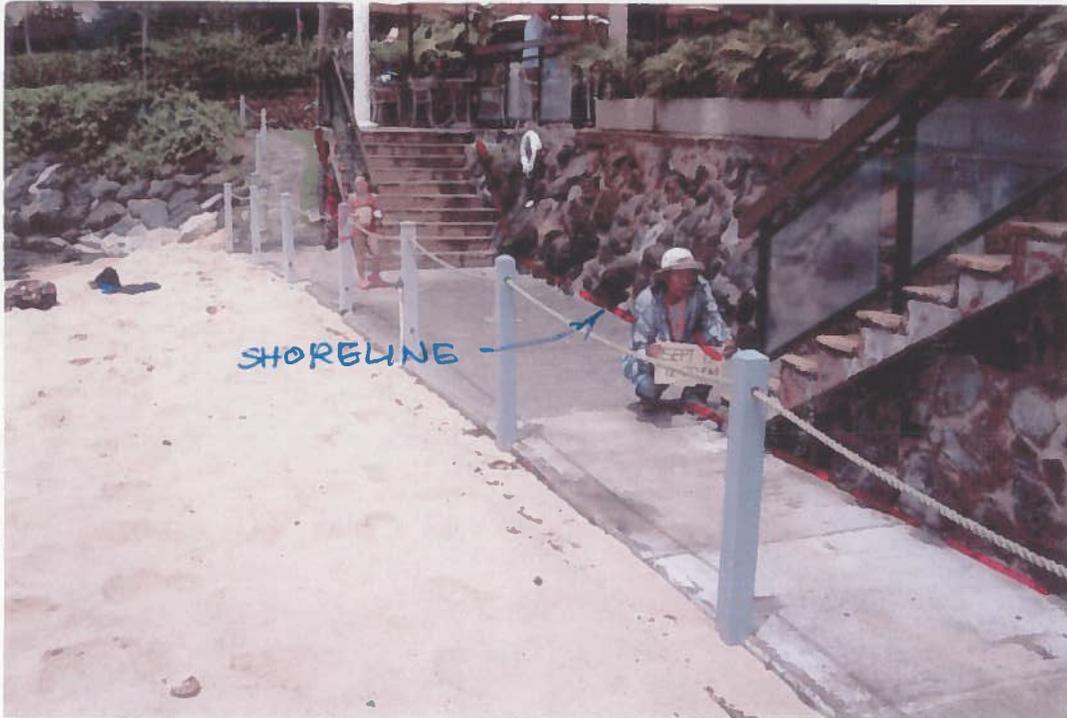
Photo # C. Taken on 9/17/13 at mid section of property looking northwestward. Shoreline follows the toe of CRM wall.

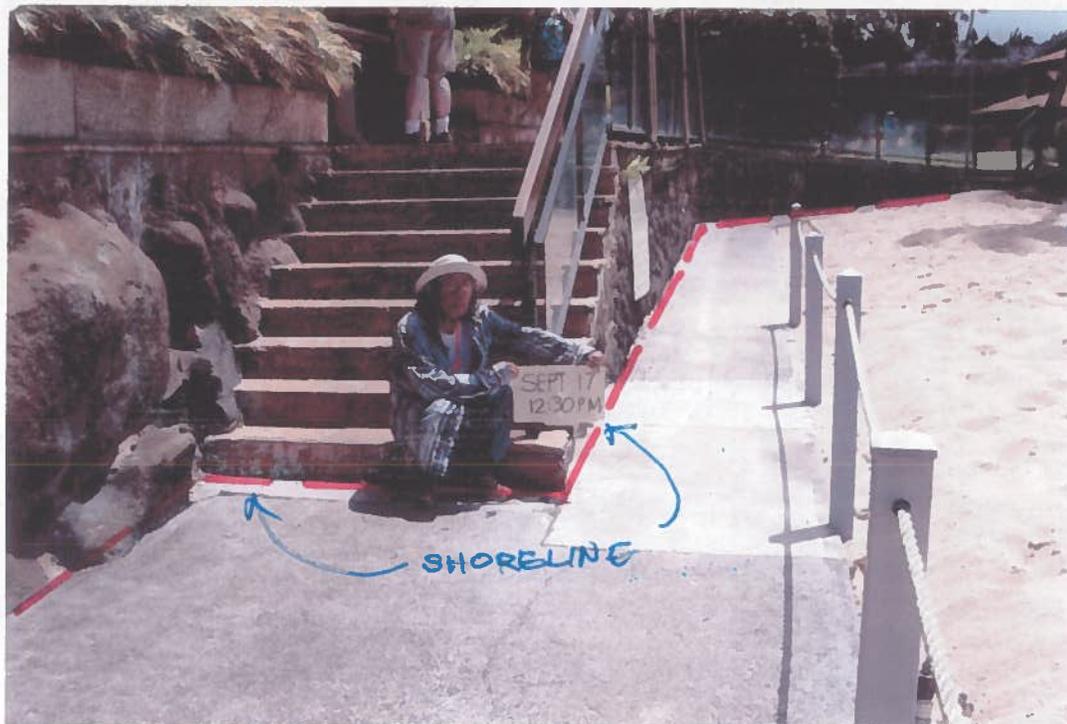
Photo # D. Taken on 9/17/13 at mid section of property looking eastward. Shoreline follows the toe of CRM wall.

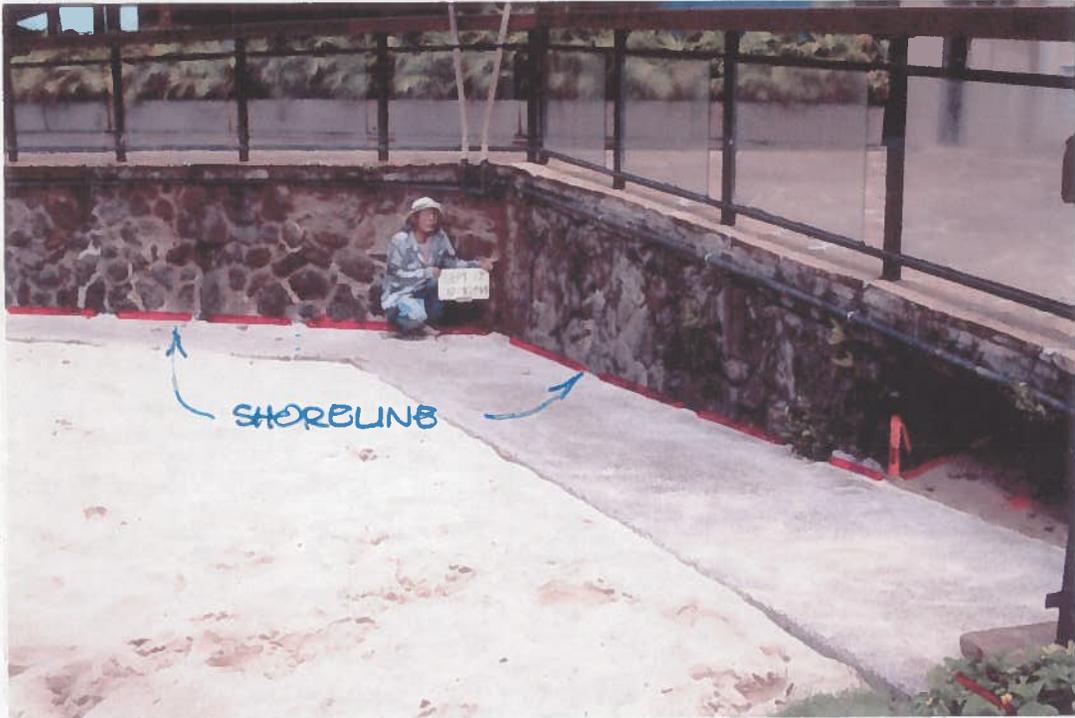
Photo # E. Taken on 9/17/13 at southwest corner of property looking northward. Shoreline follows the toe of CRM wall.

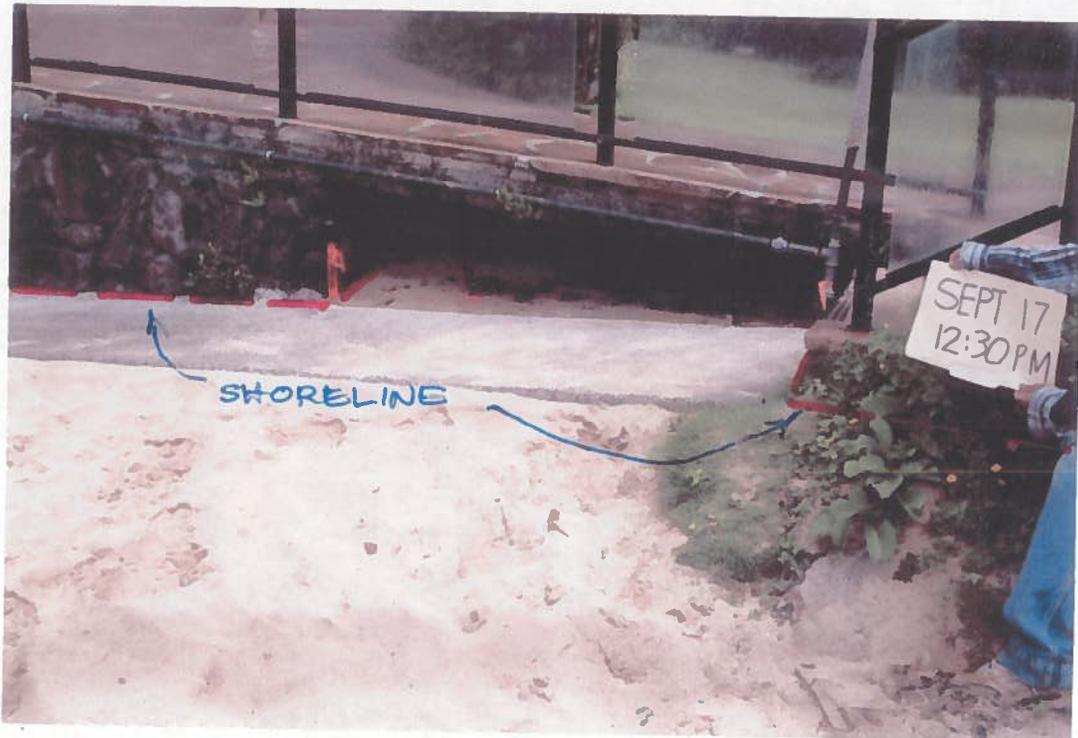
Photo # F. Taken on 9/17/13 at southwest corner of property looking eastward. Shoreline follows the toe of CRM wall underneath the concrete walkway.

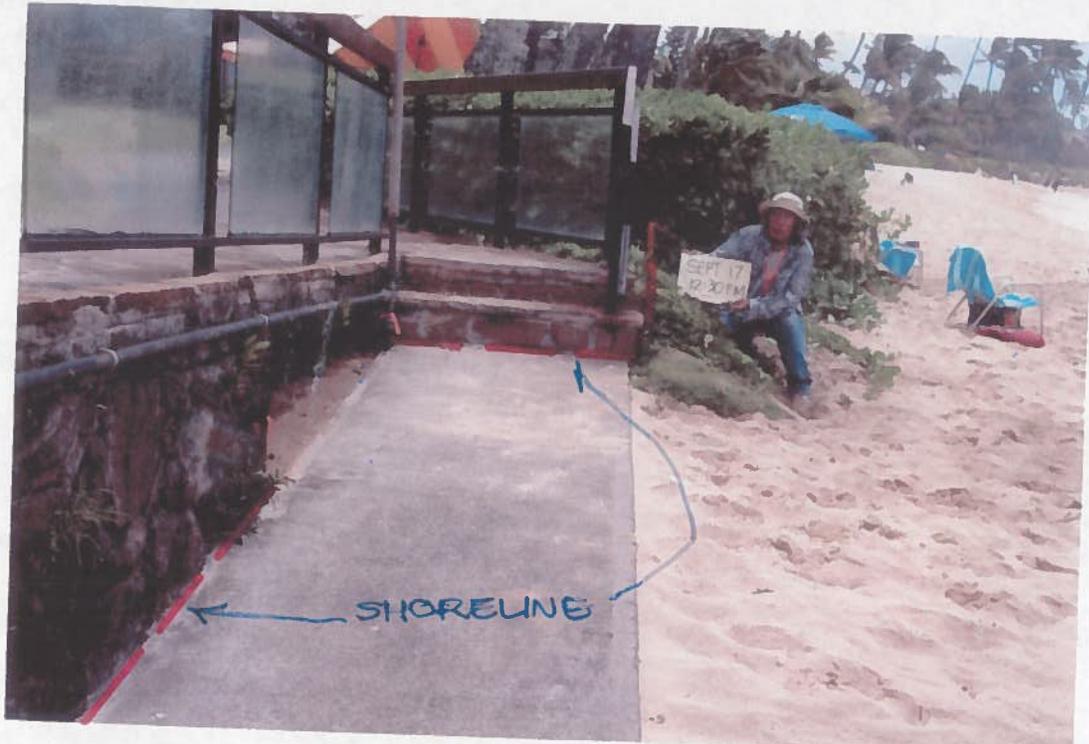
Photo # G. Taken on 9/17/13 at southwest corner of property southward. Shoreline follows the edge of concrete walkway running southward across the Bougainvillea plants.

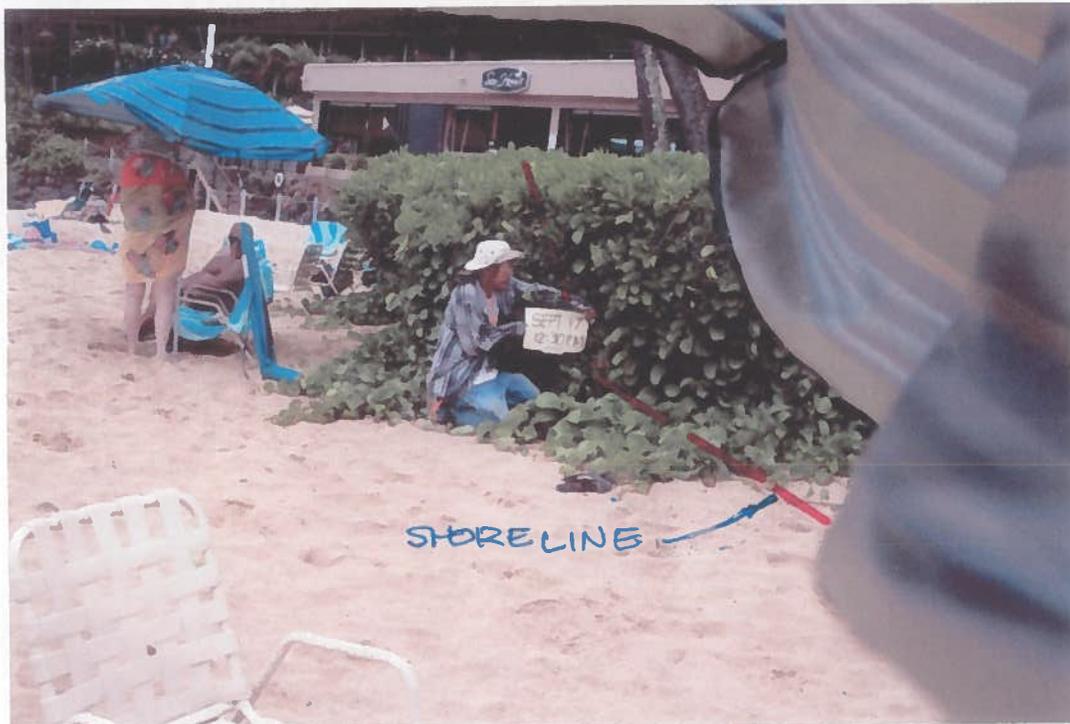
Photo # H, Taken on 9/17/13 at northwest corner of Lot 41-A looking northward. Shoreline follows the toe of Bougainvillea mound.
