**SHORELINE CERTIFICATION: PORTION OF TMK (2) 3-3-001:001**

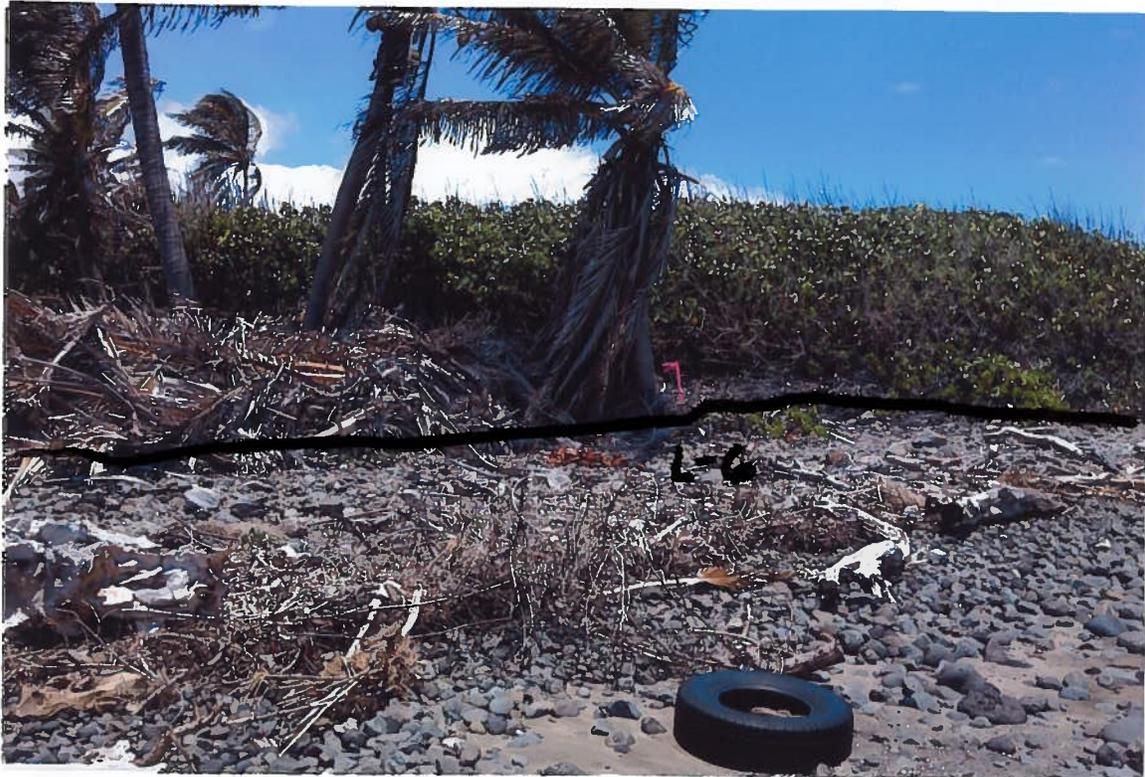
**PHOTO 1: SHORELINE AT BOTTOM OF DEBRIS PILE  
DATE: 12 NOON AUGUST 3, 2012**

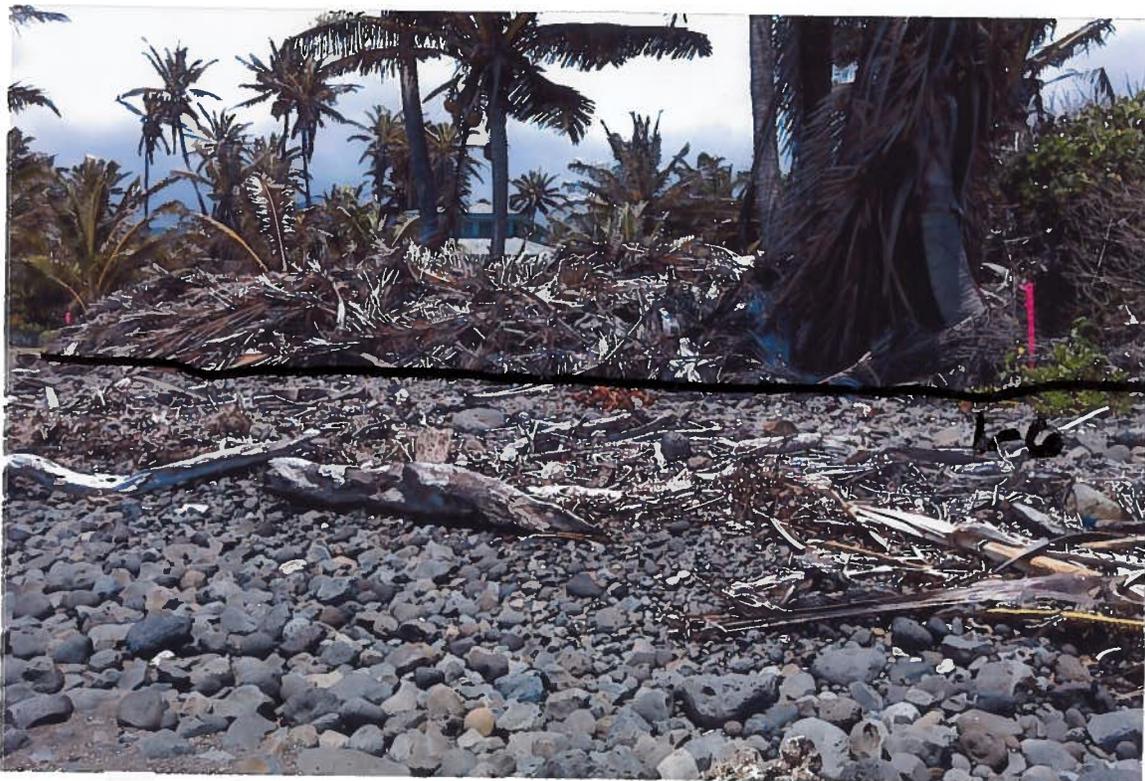
**PHOTO 2: SHORELINE AT BOTTOM OF DEBRIS PILE  
DATE: 12 NOON AUGUST 3, 2012**

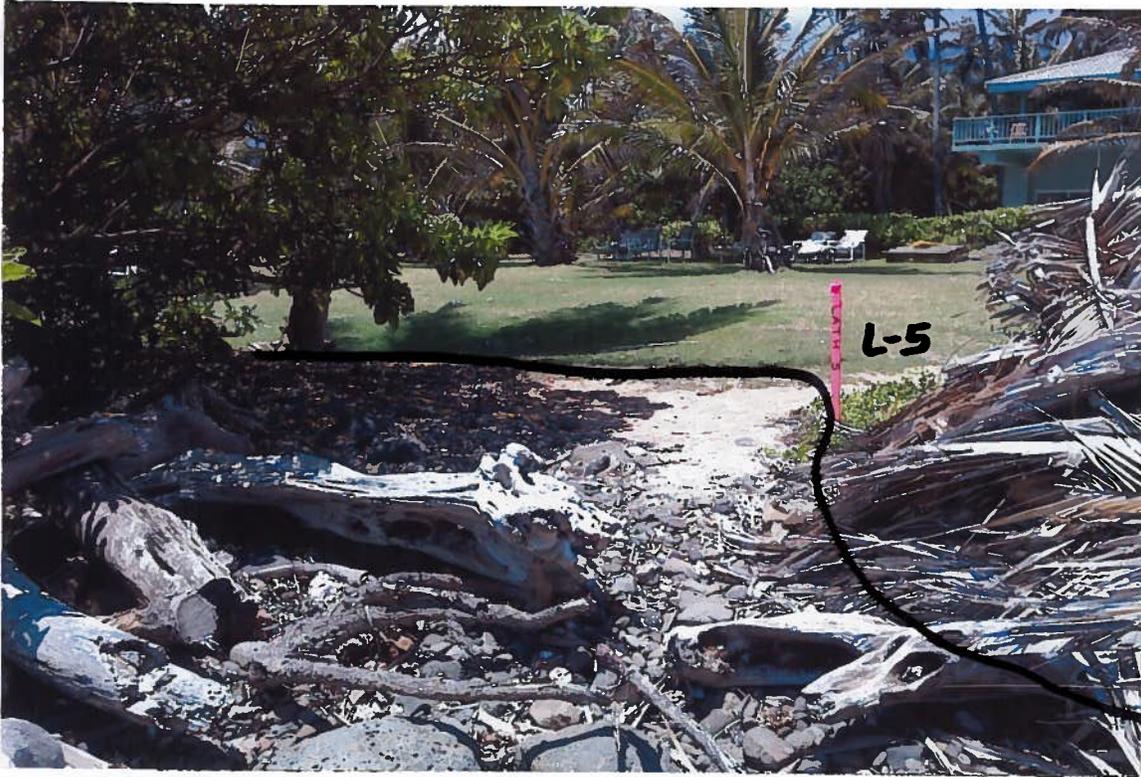
**PHOTO 3: LATH 5 AT END OF DEBRIS PILE  
FROM LATH 5 TO LATH 1 SHORELINE AT ROOTS OF  
VEGETATION AT TOP BANK  
DATE: 12 NOON AUGUST 3, 2012**

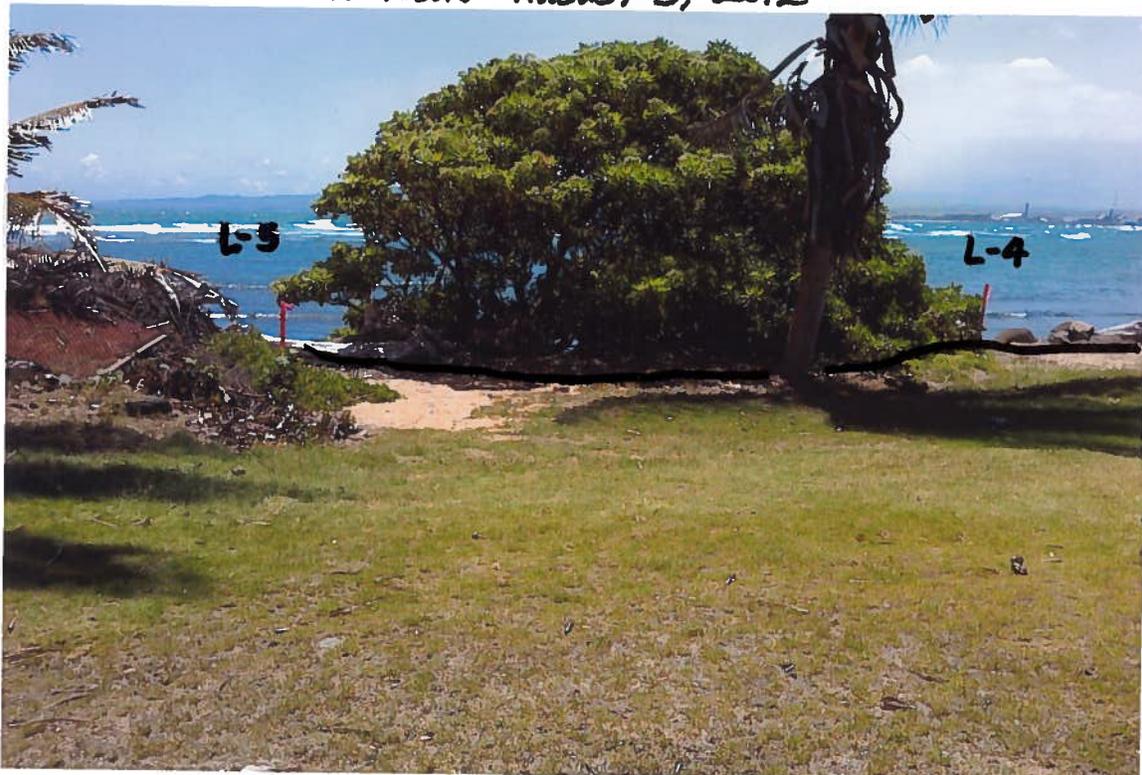
**PHOTO 4: SHORELINE AT ROOTS OF VEGETATION AT TOP BANK  
DATE: 12 NOON AUGUST 3, 2012**

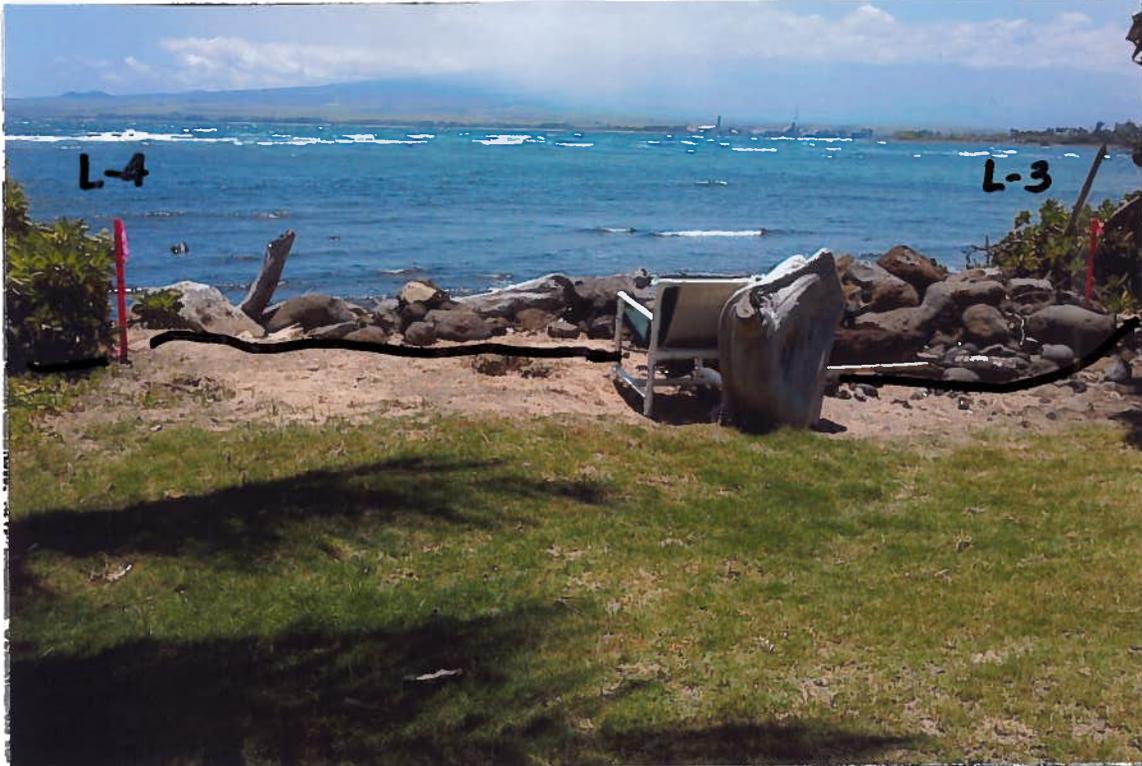
**PHOTO 5: SHORELINE AT TOP OF BANK (BARREN AREA BETWEEN LATHS 3 AND 4 DUE TO A WOODEN PLATFORM THAT WAS REMOVED)  
DATE: 12 NOON AUGUST 3, 2012**

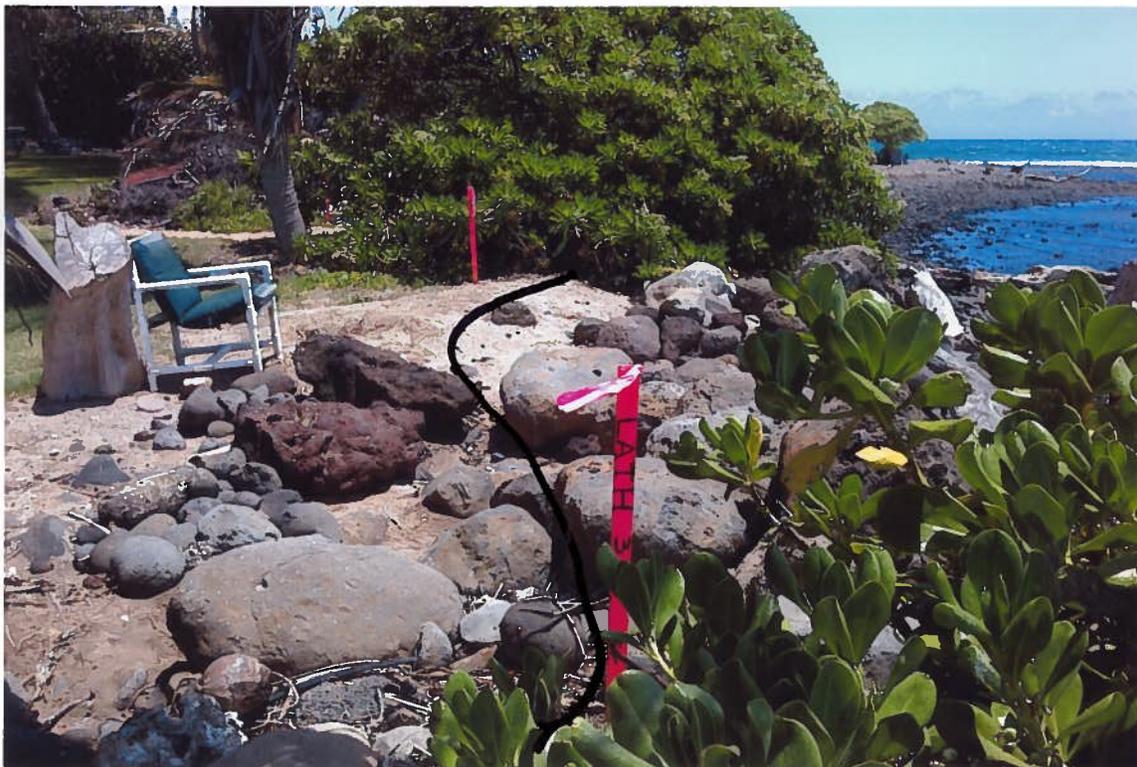
**PHOTO 6: SHORELINE AT TOP OF BANK  
REMOVED WOODEN PLATFORM BLOCKED SUNLIGHT  
TO VEGETATION  
DATE: 12 NOON AUGUST 3, 2012**

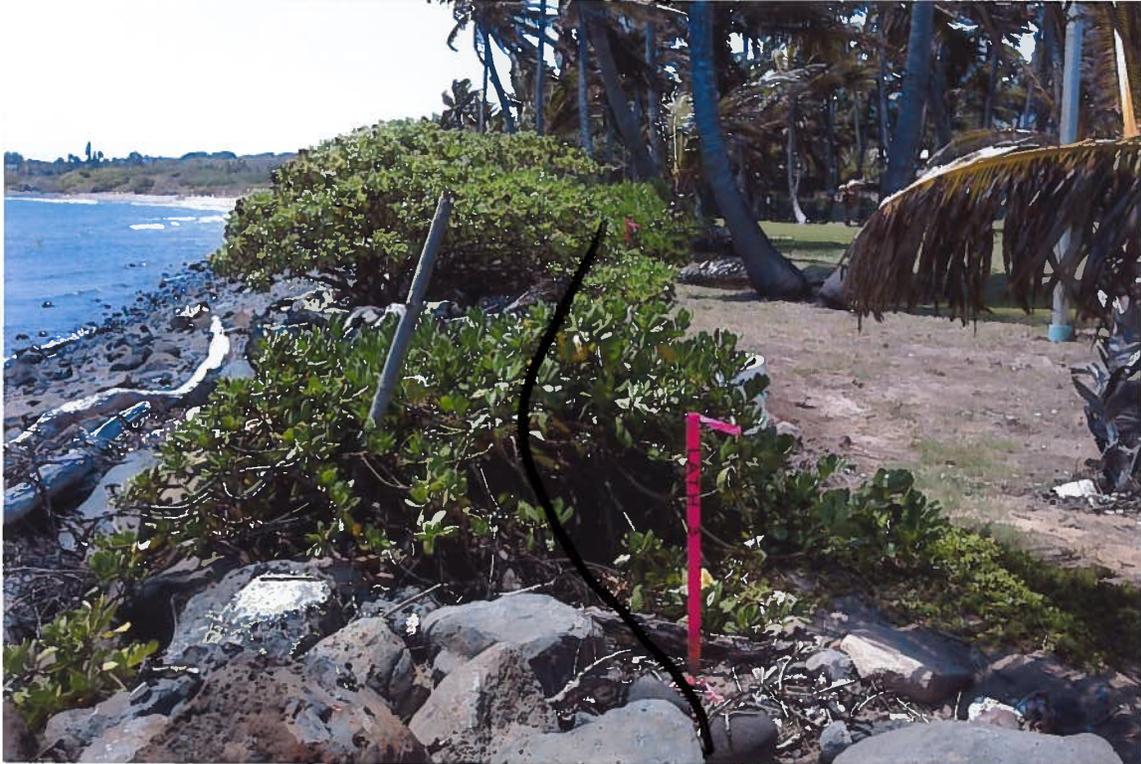
**PHOTO 7: SHORELINE AT ROOTS OF VEGETATION AT TOP OF BANK  
DATE: 12 NOON AUGUST 3, 2012**

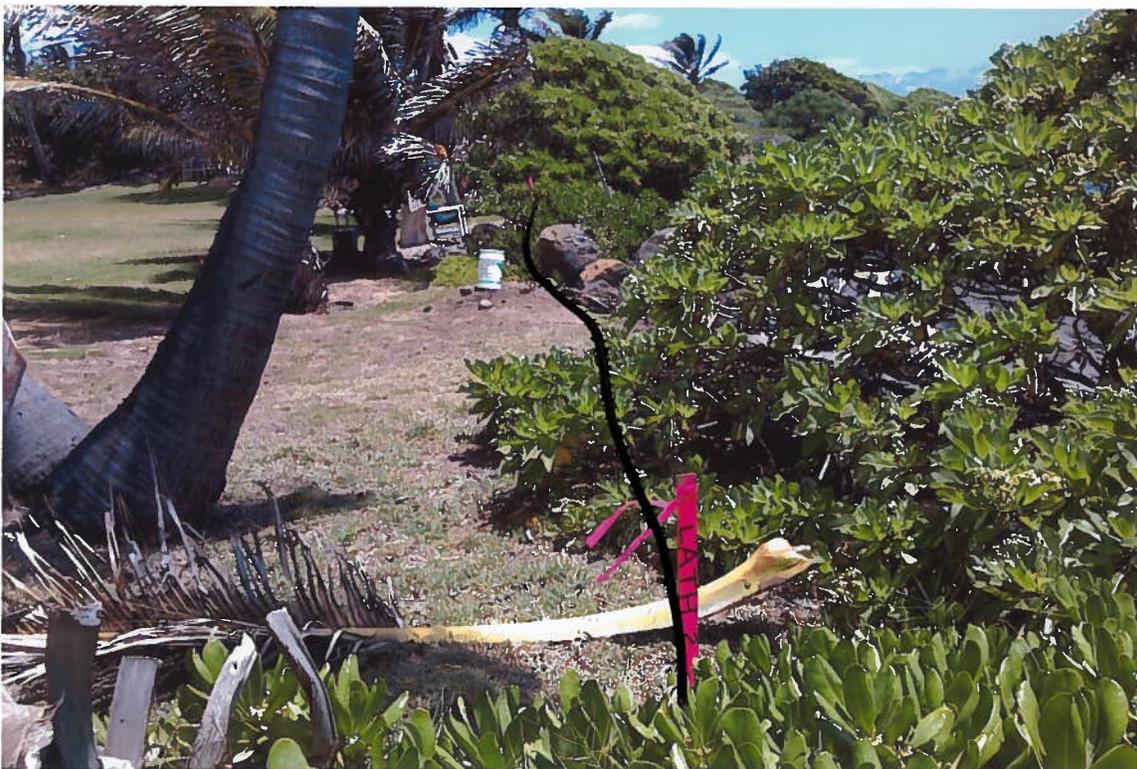
**PHOTO 8: SHORELINE AT ROOTS OF VEGETATION AT TOP OF BANK  
DATE: 12 NOON AUGUST 3, 2012**

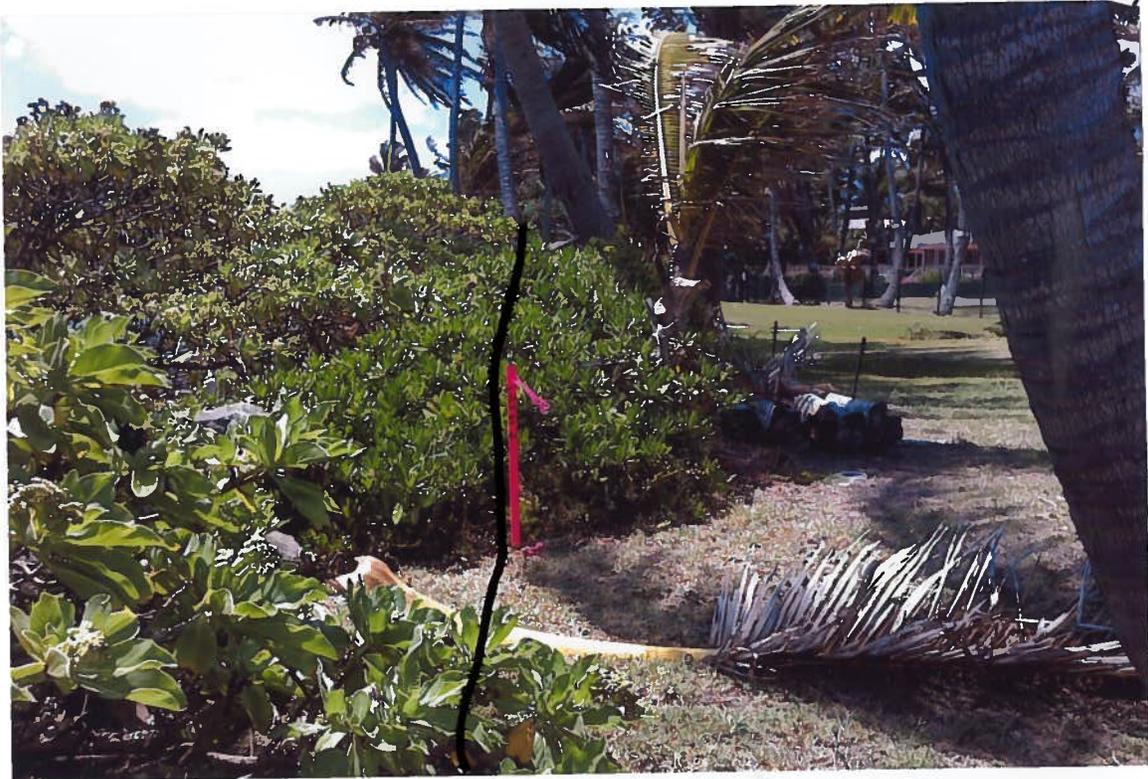
PHOTO 9: SHORELINE AT ROOTS OF VEGETATION AT TOP OF BANK  
DATE: 12 NOON AUGUST 3, 2012

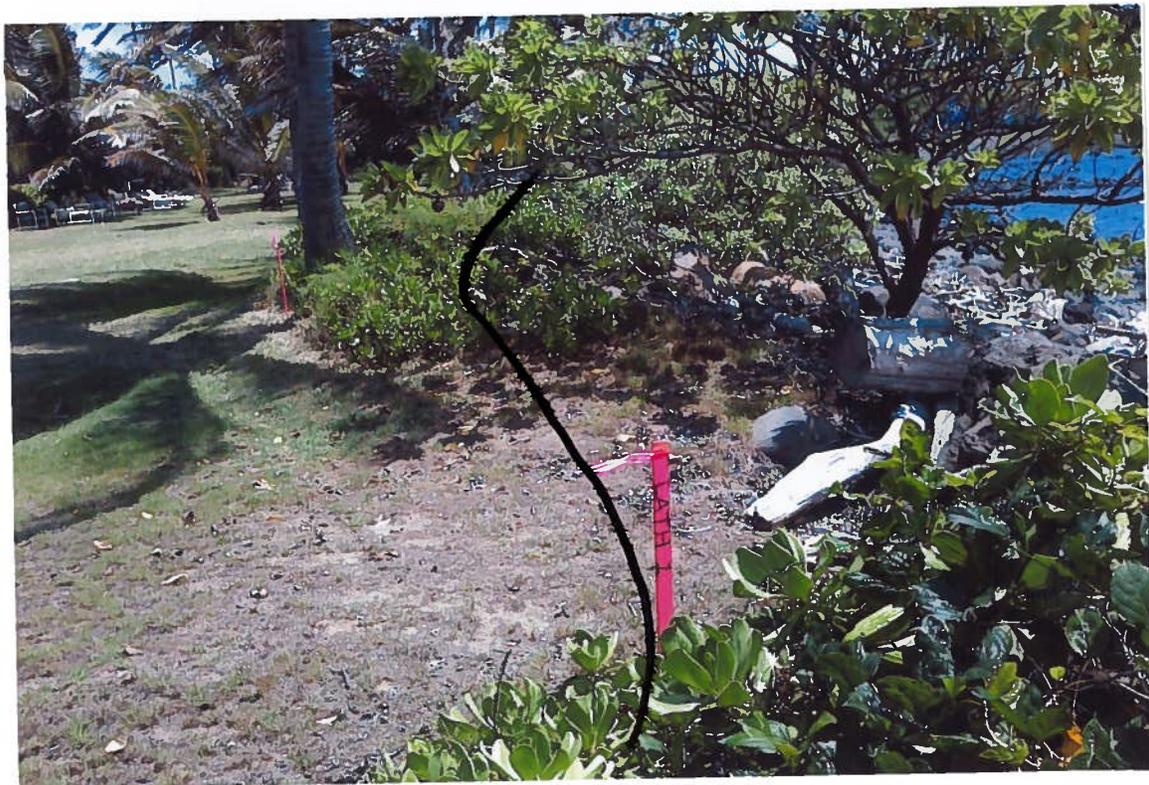
PHOTO 10: SHORELINE AT ROOTS OF VEGETATION AT TOP OF BANK  
DATE: 12 NOON AUGUST 3, 2012
