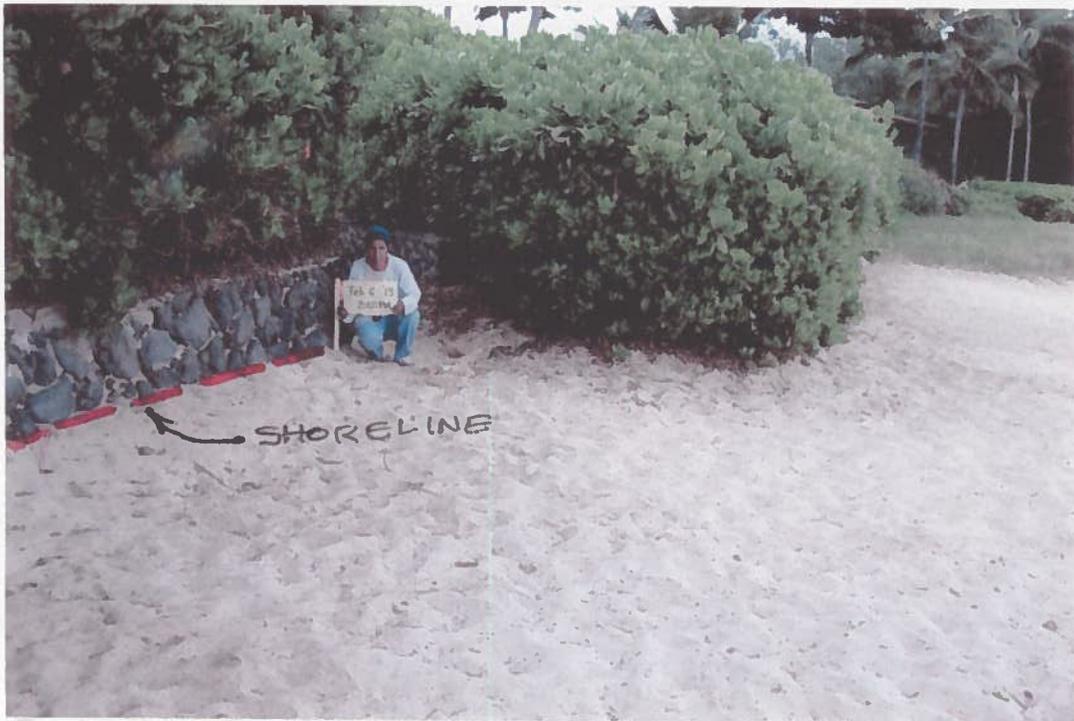
Photo # 1. Taken at the S-E corner of property looking southeasterly. "Shoreline" follows the seaward face of CRM wall.

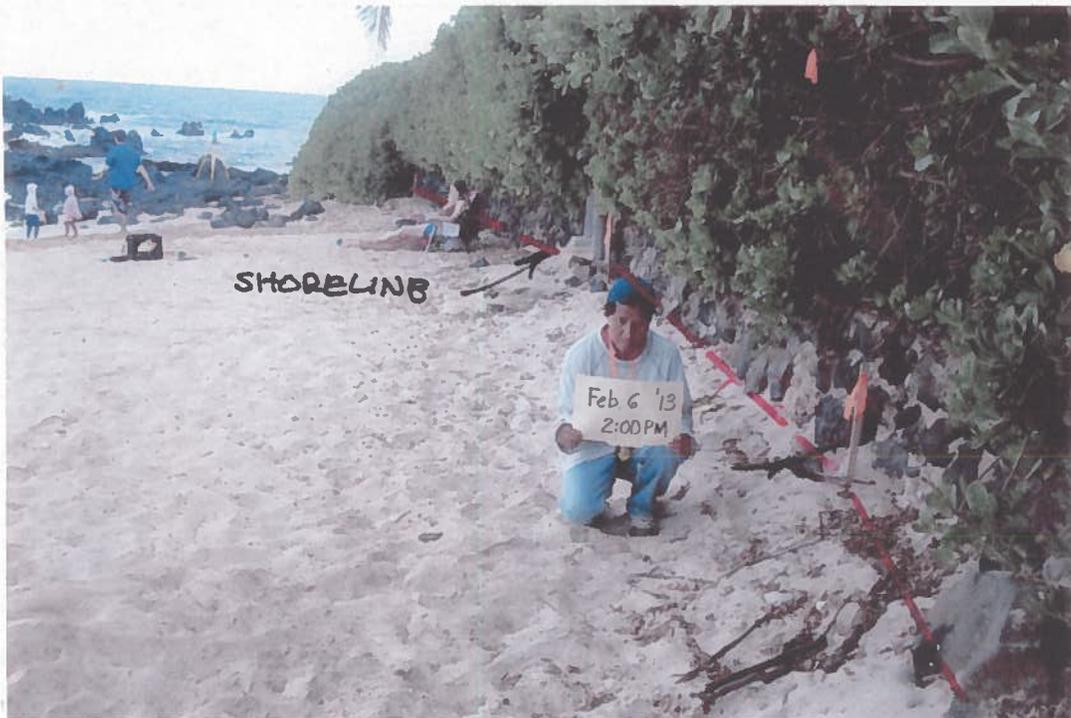
Photo # 2. Taken at the S-E corner of property looking westward. "Shoreline" follows the seaward face of CRM wall.

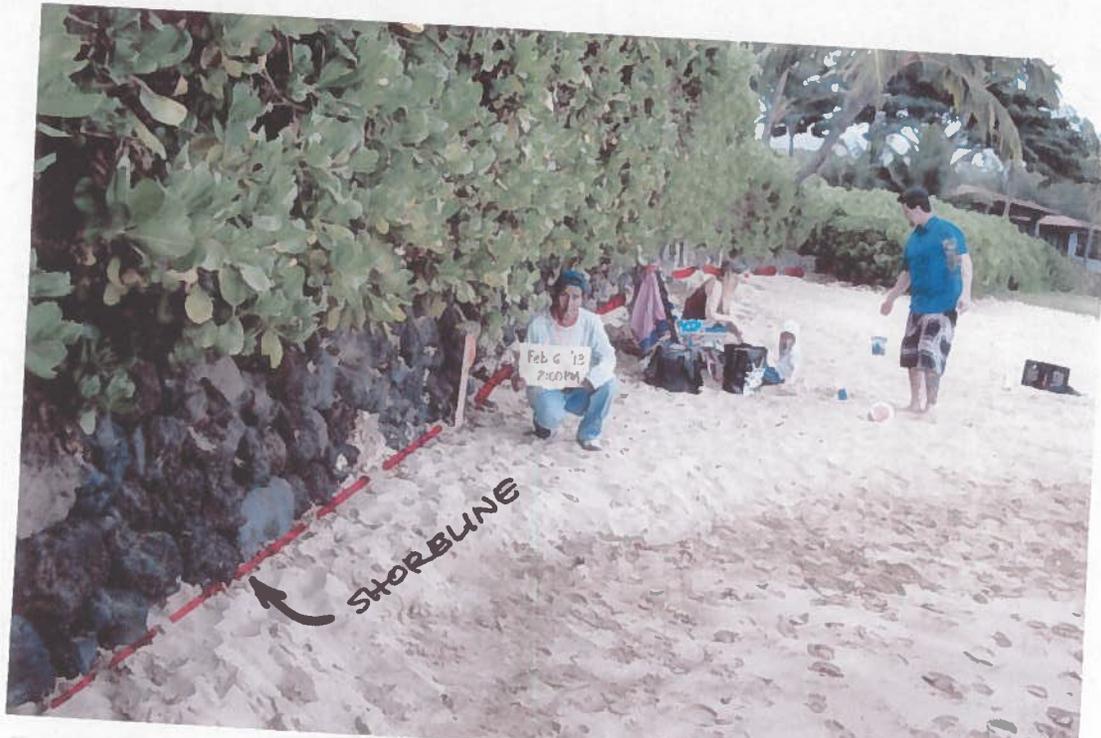
Photo # 3. Taken at south side of property looking easterly. "Shoreline" follows the seaward face of CRM wall.

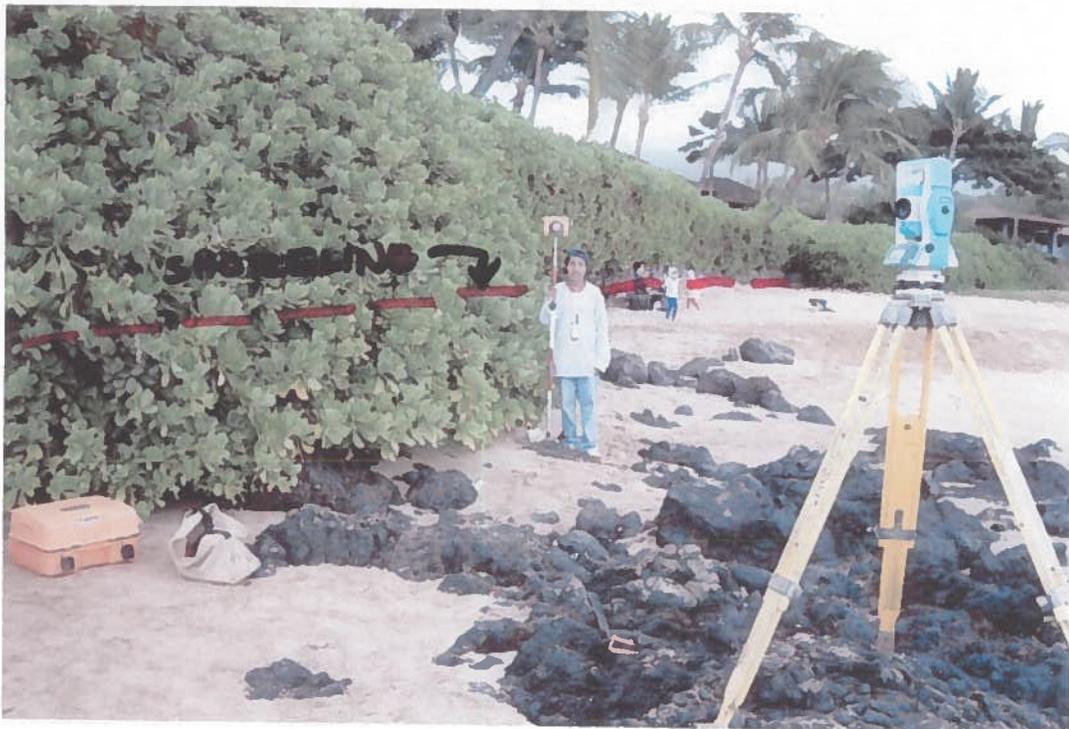
Photo # 4, Taken at south side of property looking easterly. "Shoreline" follows the seaward face of CRM wall which is partially hidden by vegetation.

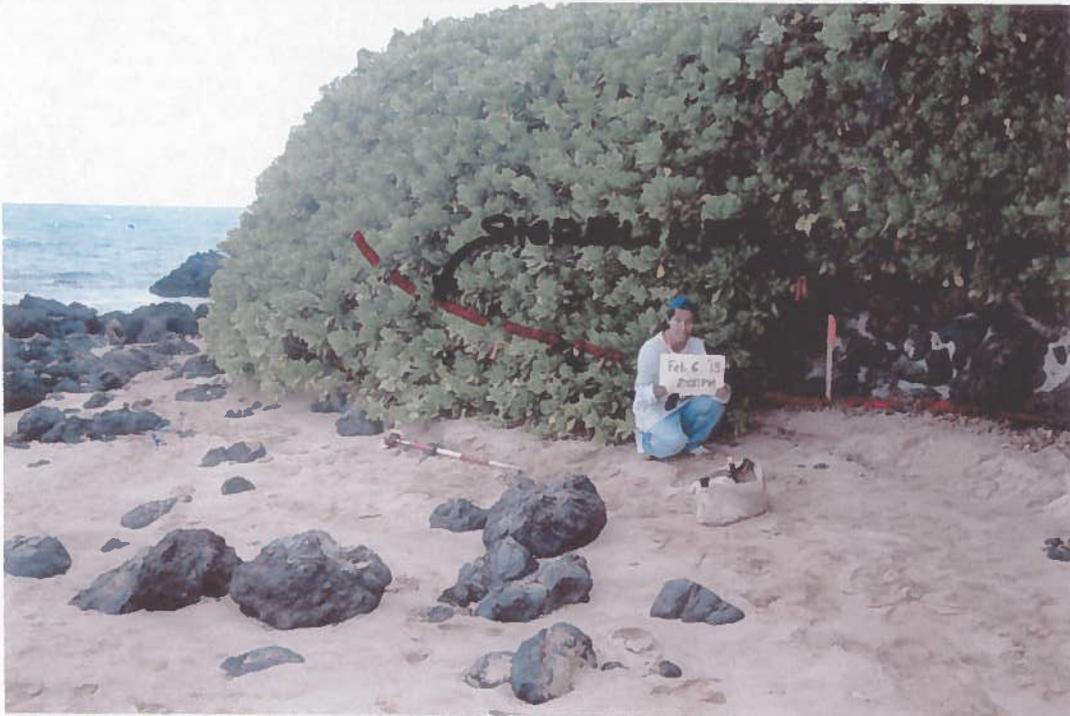
Photo # 5. Taken at the southend of property looking northward. "Shoreline" follow the seaward face of CRM wall as partially hidden by the Naupaka vegetation.

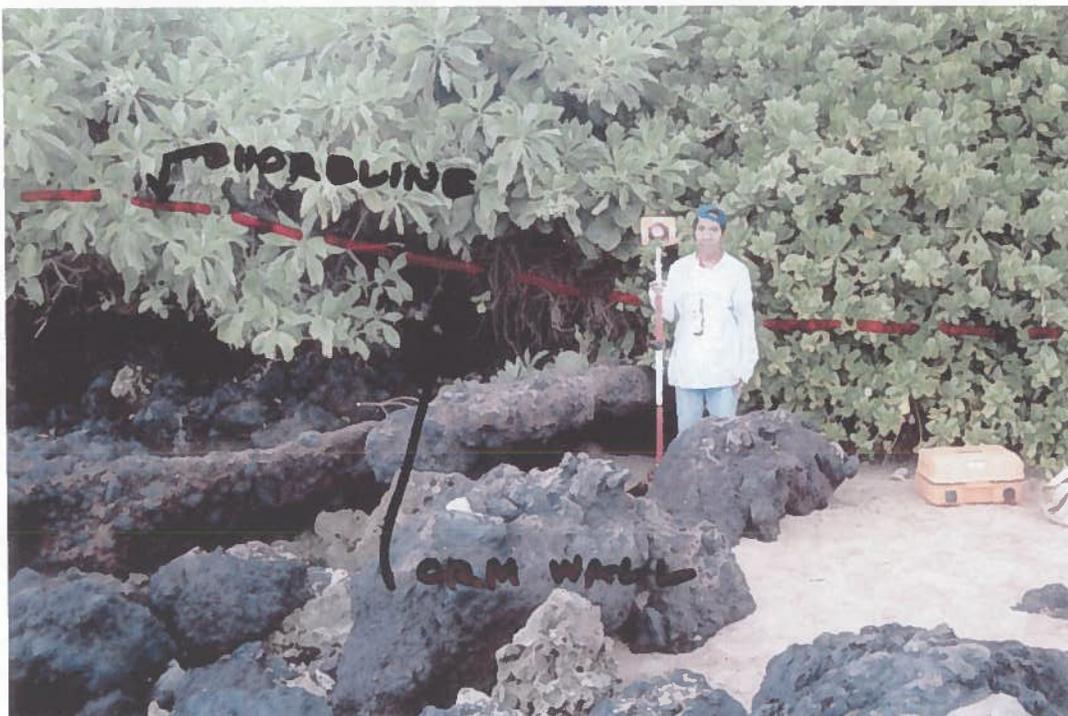
Photo # 6. Taken at the southend of property @ survey station looking northward. "Shoreline" follows the seaward face of CRM wall as hidden by the Naupaka vegetation.

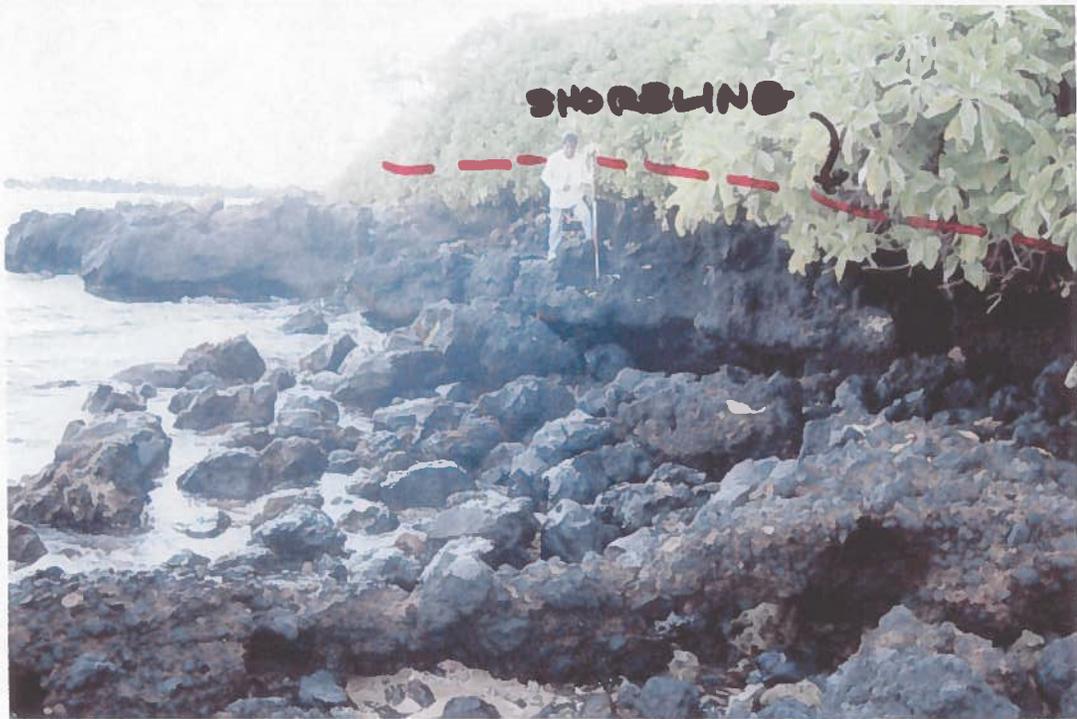
Photo # 7. Taken at southwest corner of property looking northwesterly. "Shoreline" follows the sea face of CRM wall and vegetation line.

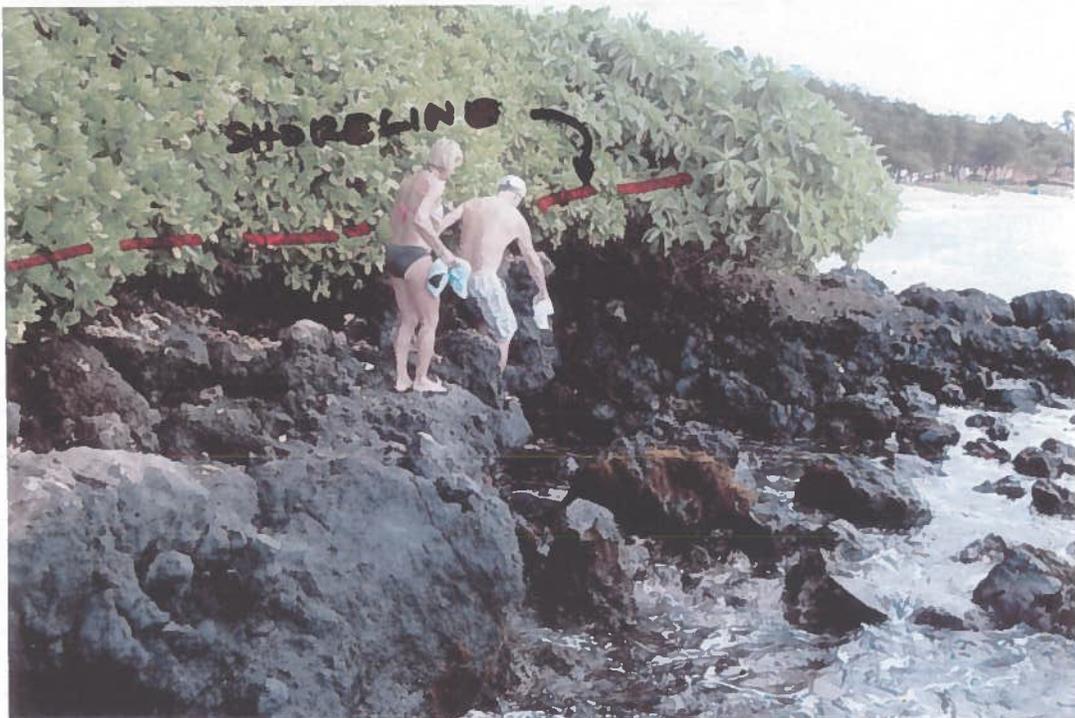
Photo # 8. Taken at the southwest corner of property looking southeasterly. "Shoreline" follows vegetation line.

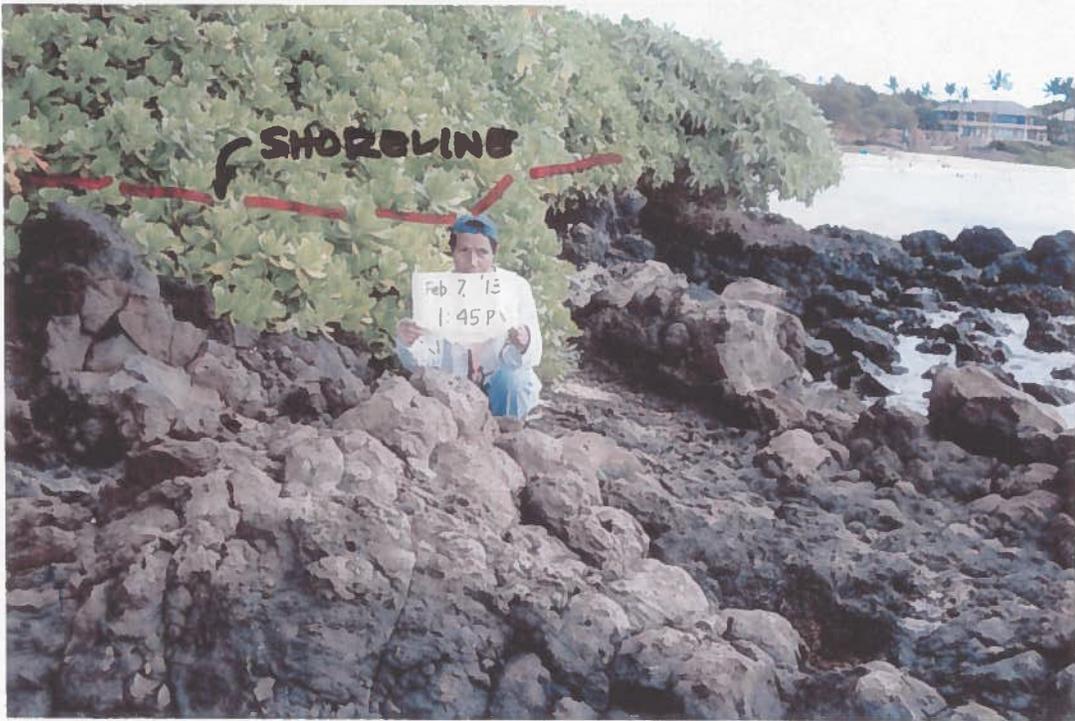
Photo # 9. Taken at near mid section of the shoreline boundary looking southeasterly. "Shoreline" follows vegetation line and seaward face of CRM wall which is hidden.

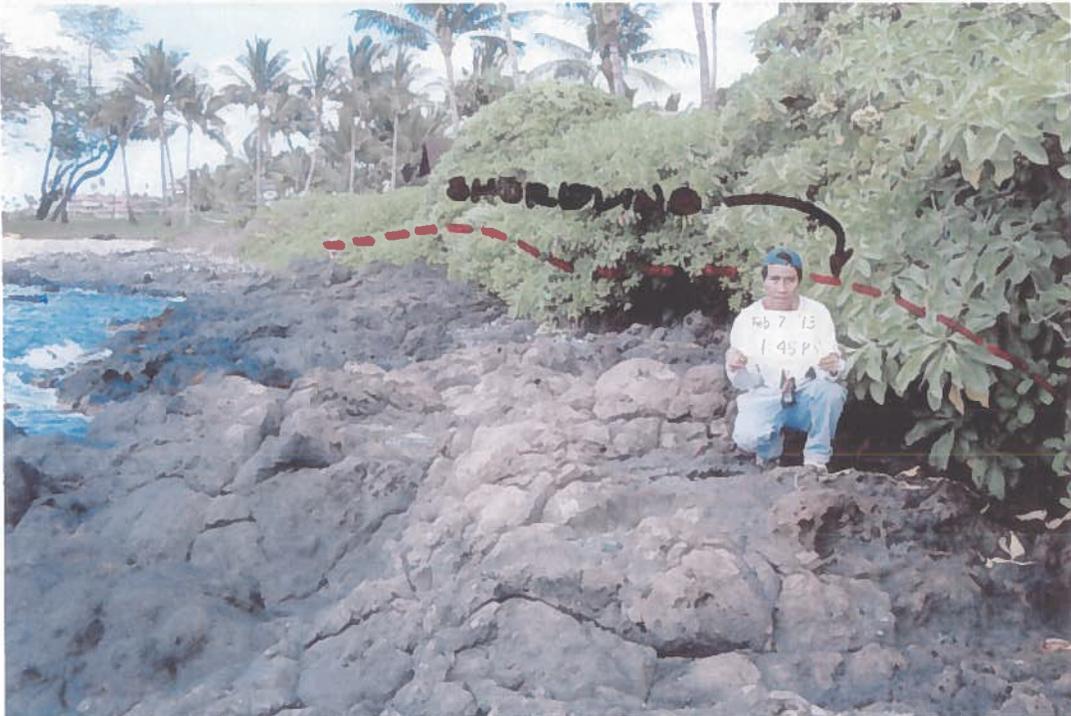
Photo # 10. Taken at near mid-section of shoreline boundary looking northward. "Shoreline" follows vegetation line.

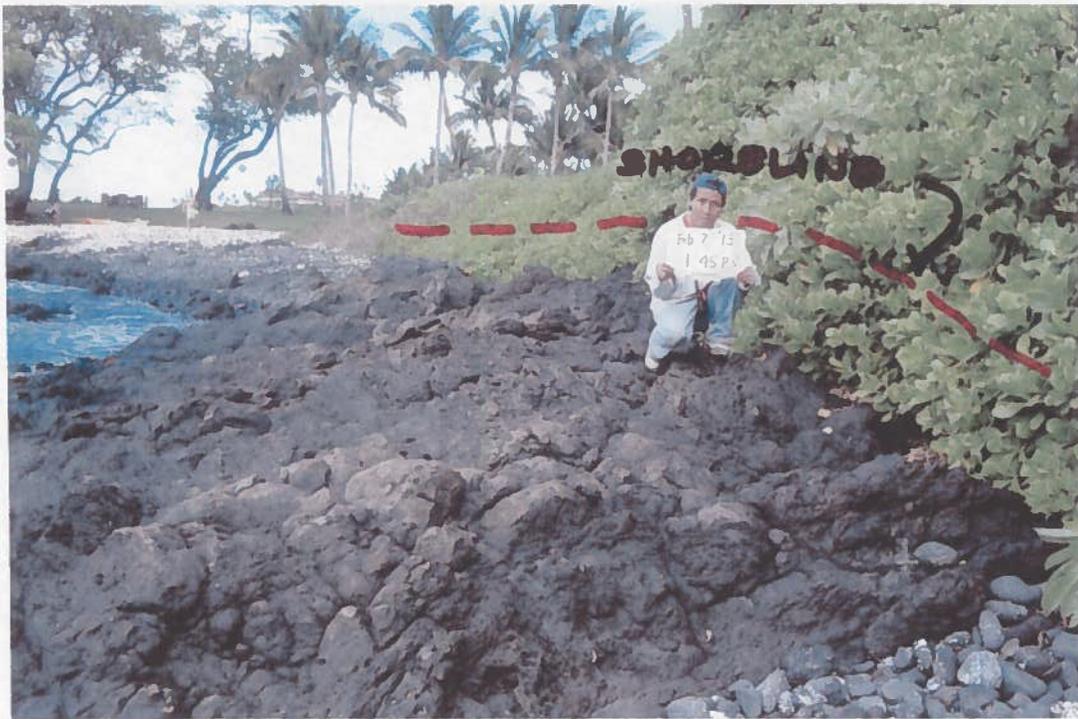
Photo # 11. Taken at near mid-section of shoreline boundary looking northward. "Shoreline" follows vegetation line.

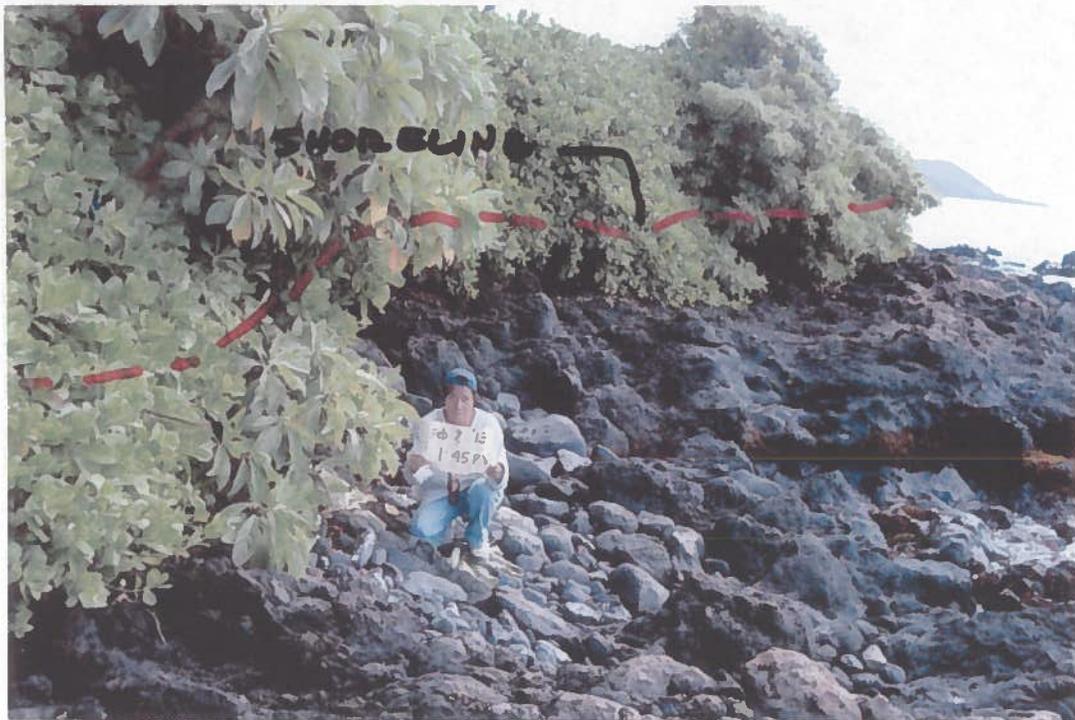
Photo # 12. Taken at near mid-section of shoreline boundary looking southward. "Shoreline" follows vegetation line.

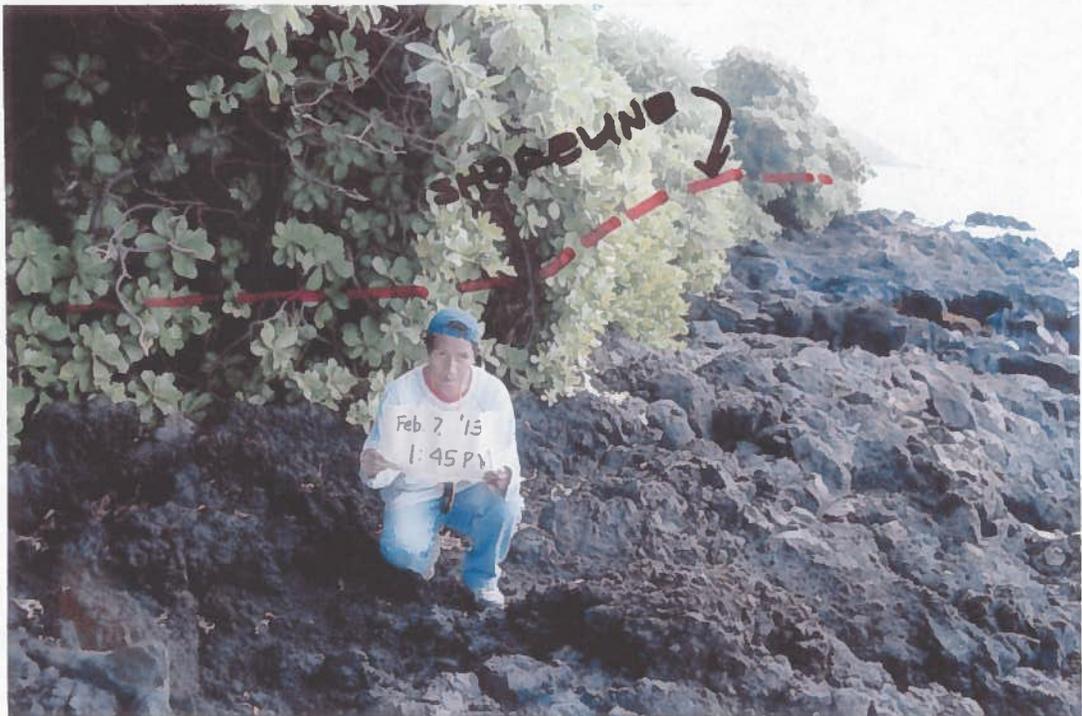
Photo # 13. Taken at near northwest corner of property looking southward. "Shoreline" follows vegetation line.

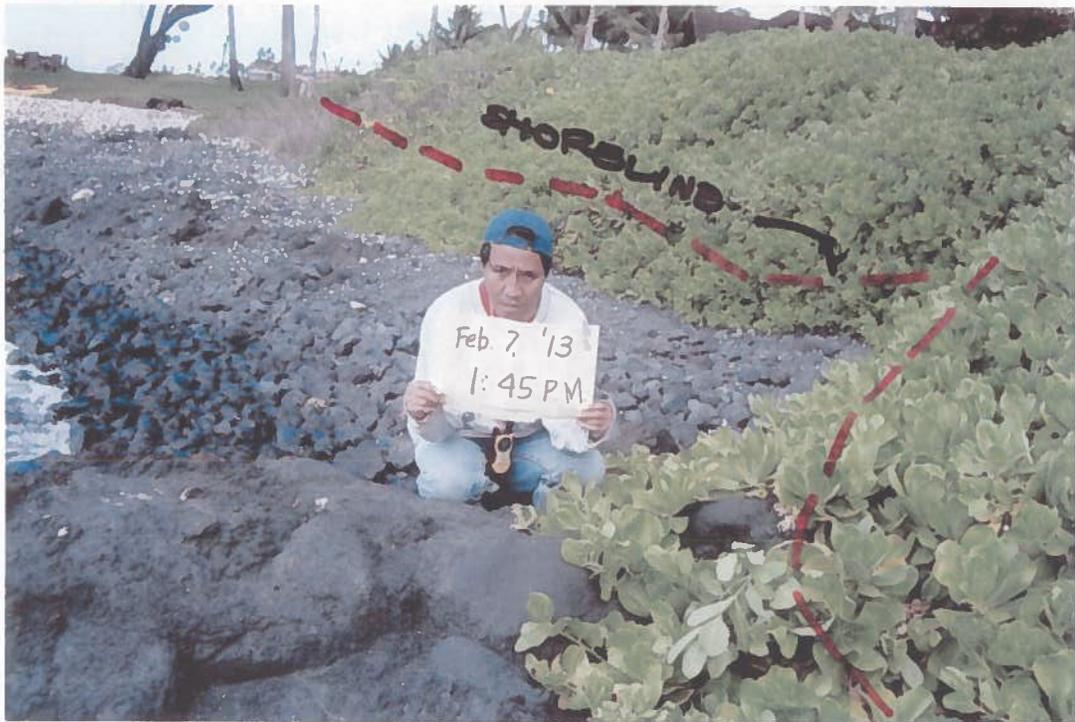
Photo # 14. Taken at near northwest corner of property looking northeasterly. "Shoreline" follows the vegetation line and top of bank (hidden by the Naupaka vegetation).

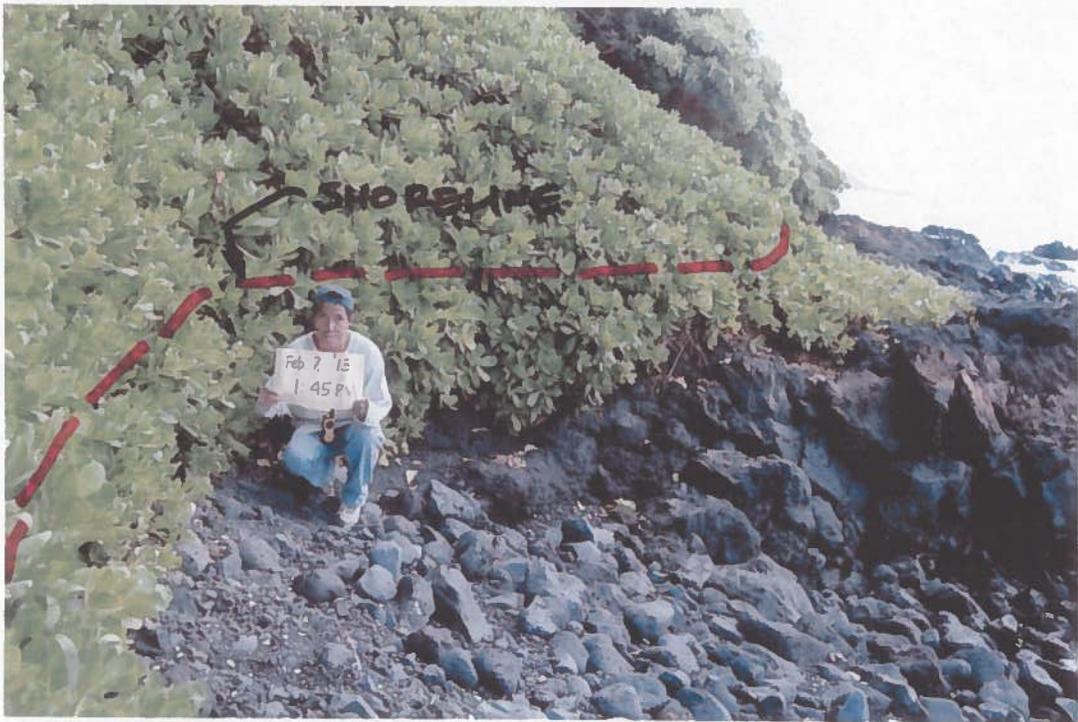
Photo # 15. Taken at near northwest corner of property looking southward. "Shoreline" follows vegetation line.

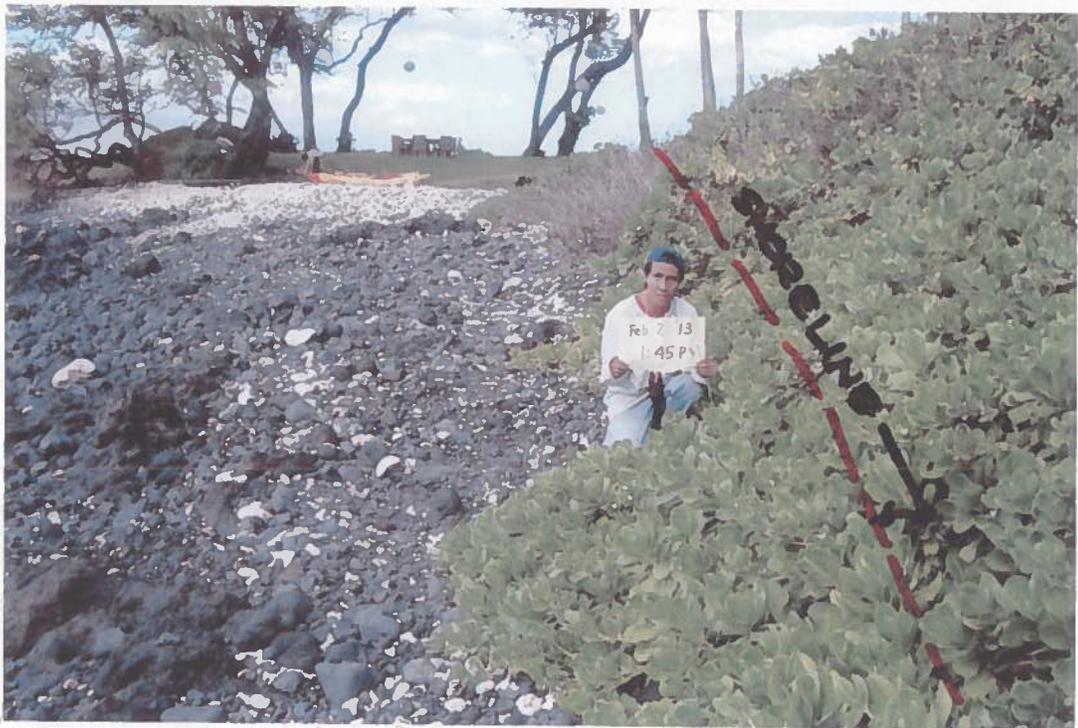
Photo # 16. Taken at near northwest corner of property looking northward. "Shoreline" follows top of bank hidden by vegetation line.

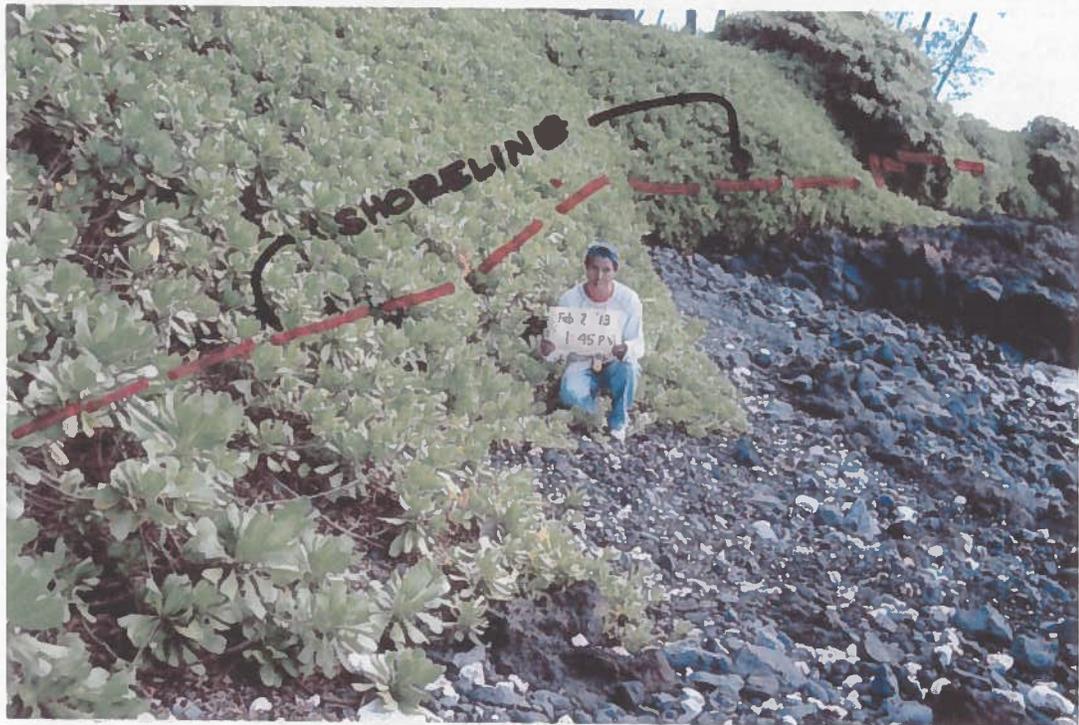
Photo # 17. Taken at northwest corner of property looking southward. "Shoreline" follows top of bank which is hedden by vegetation line.

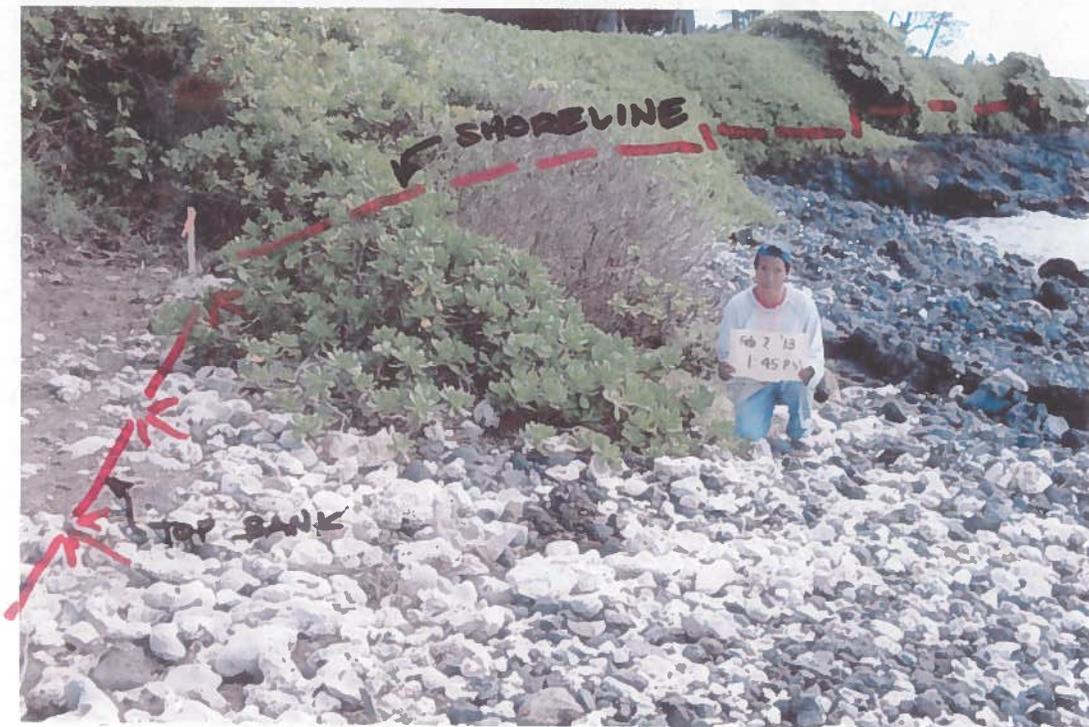
Photo # 18. Taken at northwest corner of property looking southward. "Shoreline" follows top of bank which is covered by the vegetation.
