SHORELINE CERTIFICATION OF LOT D-1 CROWELL-RAYMOND PARTITION
TMK (2) 2-9-010:025
621 HANA HIGHWAY KUAU, PAIA, MAUI, HI

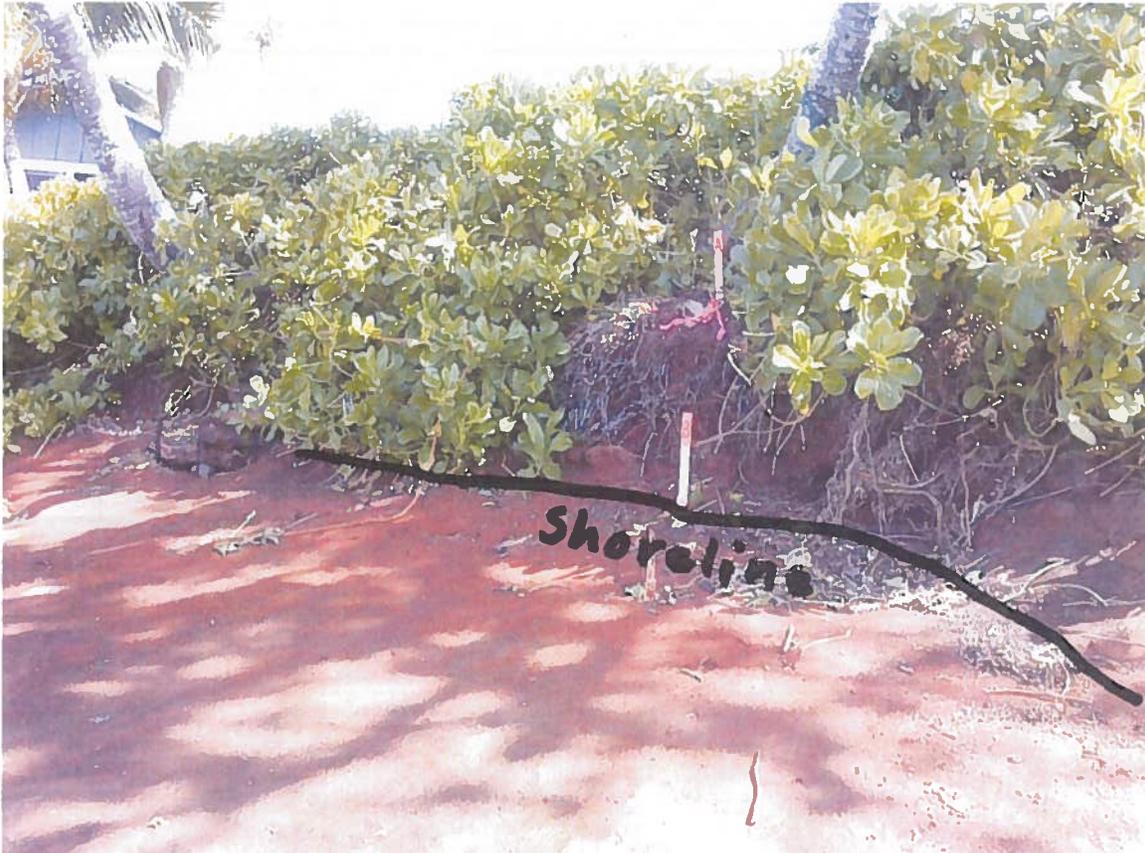
PHOTO 1: A STEEL SPIKE AT THE TOP OF THE EMBANKMENT MARKED BY LATH A REPRESENTS THE RECORD SEAWARD CORNER OF LOT D-1, TMK (2) 2-6-010:025 AND LOT E TMK (2) 2-6-010:026 (DOC. 2008-140553) AND THE SHORELINE AS LOCATED ON APRIL 29, 2011 AND CERTIFIED ON AUGUST 17, 2011.

LATH B AT THE BOTTOM OF THE EMBANKMENT MARKS THE SHORELINE AS LOCATED ON MARCH 19, 2015.

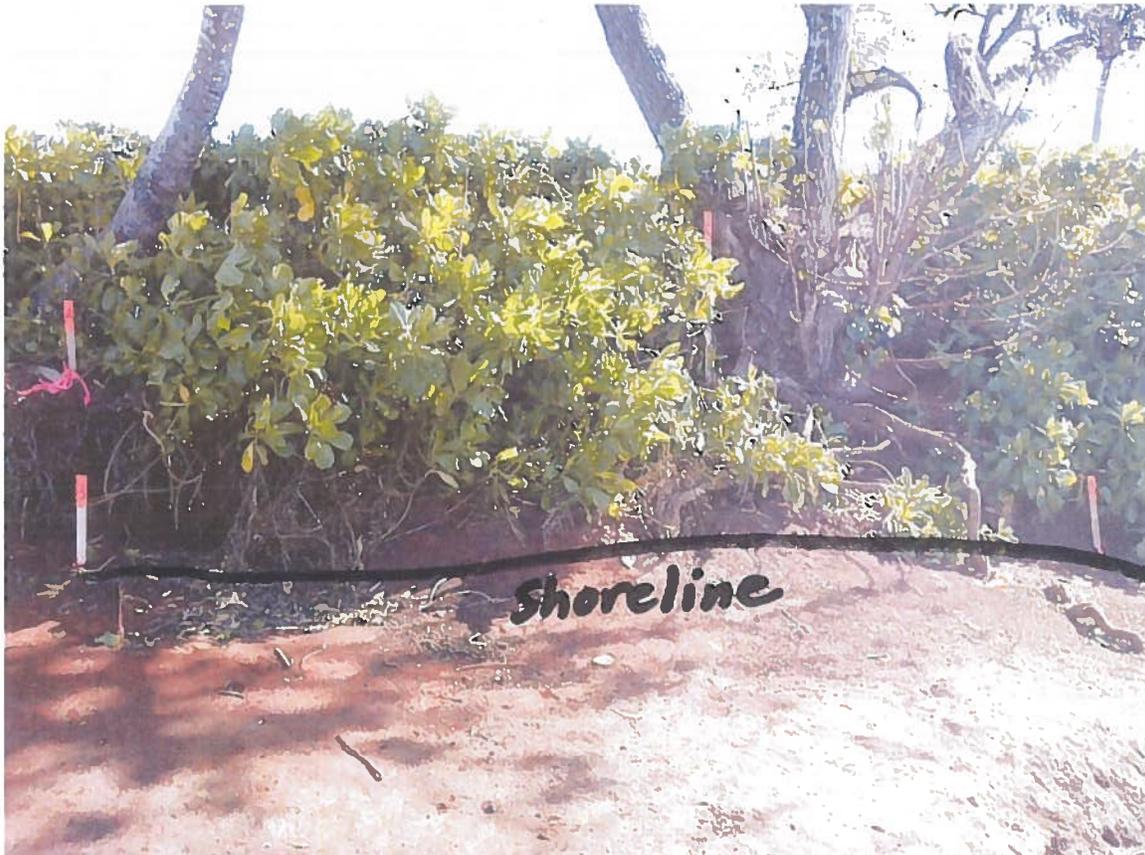
PHOTO 2: LOOKING AT LATHS A AND B (LEFT) AND LATHS C AND D (RIGHT). A STEEL SPIKE AT THE TOP OF THE EMBANKMENT MARKED BY LATH C REPRESENTS A RECORD SEAWARD CORNER OF LOT D-1, TMK (2) 2-6-010:025 (DOC. 2008-140553) AND THE SHORELINE AS LOCATED ON APRIL 29, 2011 AND CERTIFIED ON AUGUST 17, 2011.

LATHS B AND D AT THE BOTTOM OF THE EMBANKMENT MARK THE SHORELINE AS LOCATED ON MARCH 19, 2015.

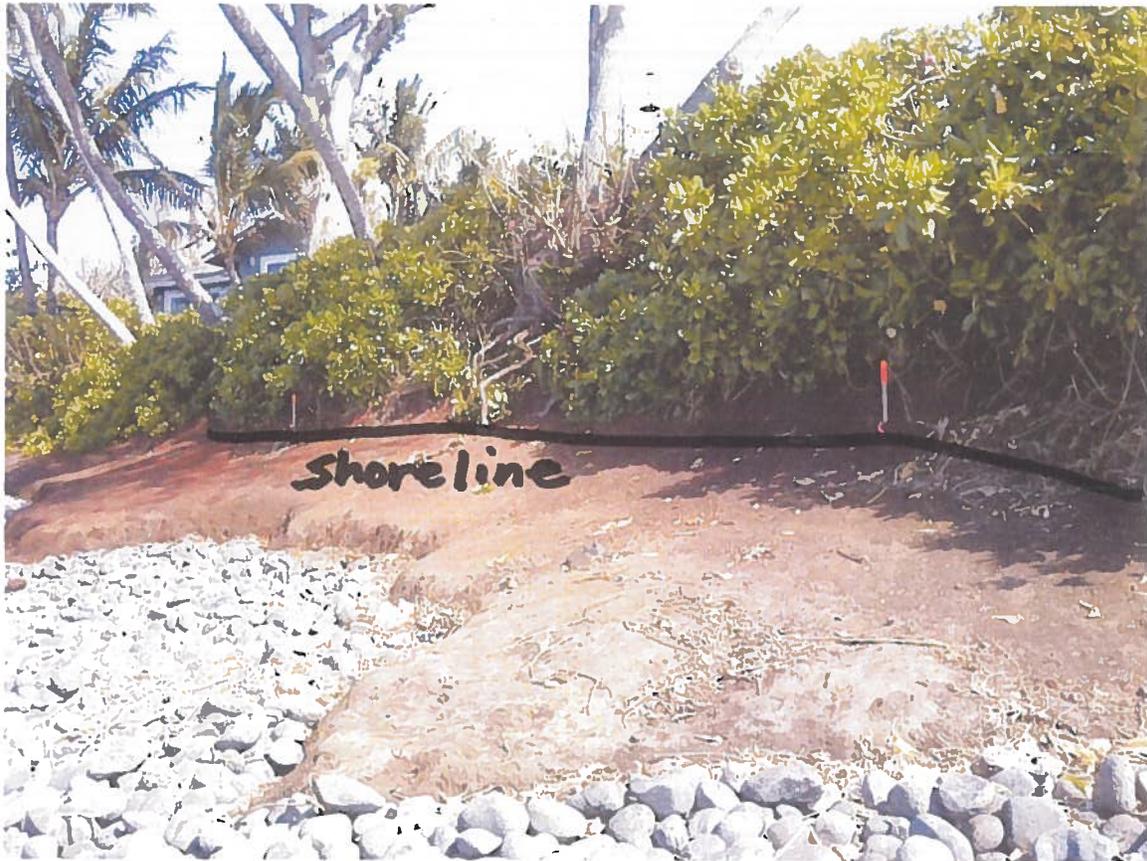
PHOTO 3: LOOKING EASTWARD AT LATH B (LEFT) AND LATH E (RIGHT FOREGROUND).

LATHS B, D (NOT CLEARLY VISIBLE) AND LATH E AT THE BOTTOM OF THE EMBANKMENT MARK THE SHORELINE AS LOCATED ON MARCH 19, 2015.

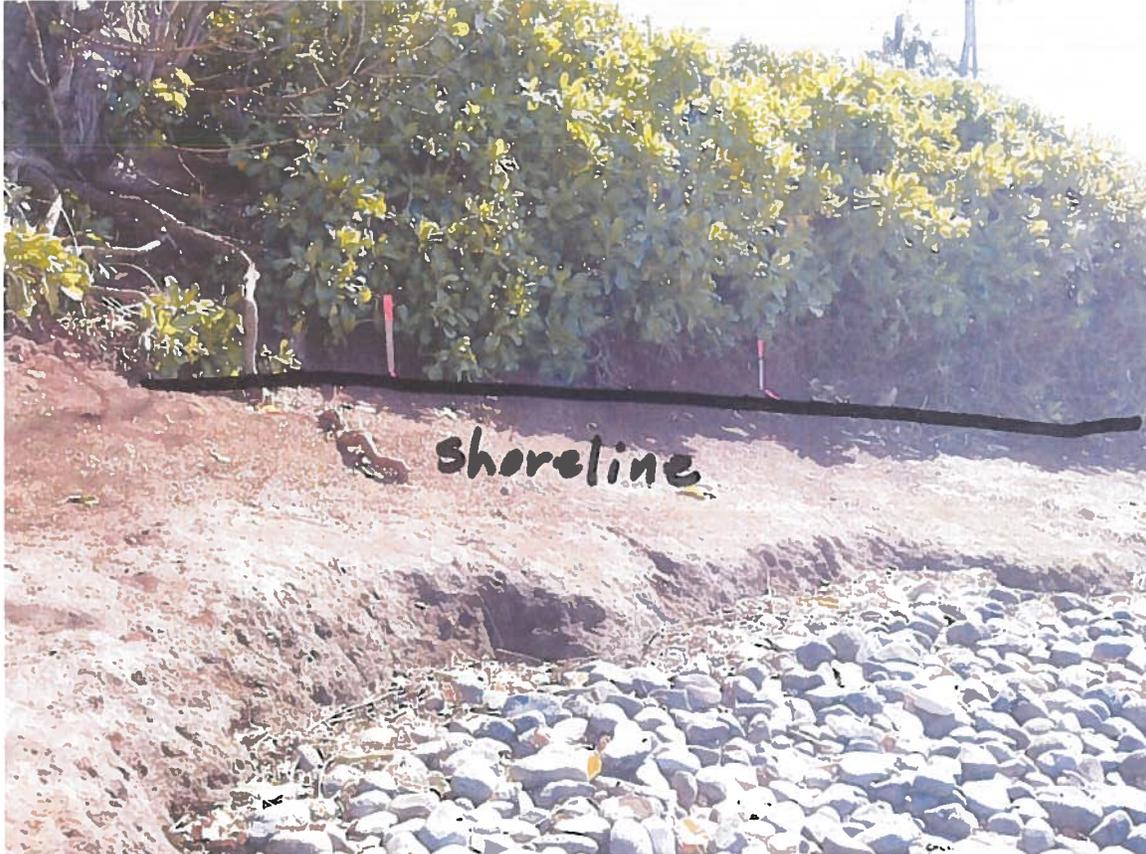
PHOTO 4: LOOKING SOUTH AT LATHS D AND LATH E . THE SHORELINE AS LOCATED ON MARCH 19, 2015 FOLLOWS THE BOTTOM OF THE EMBANKMENT.

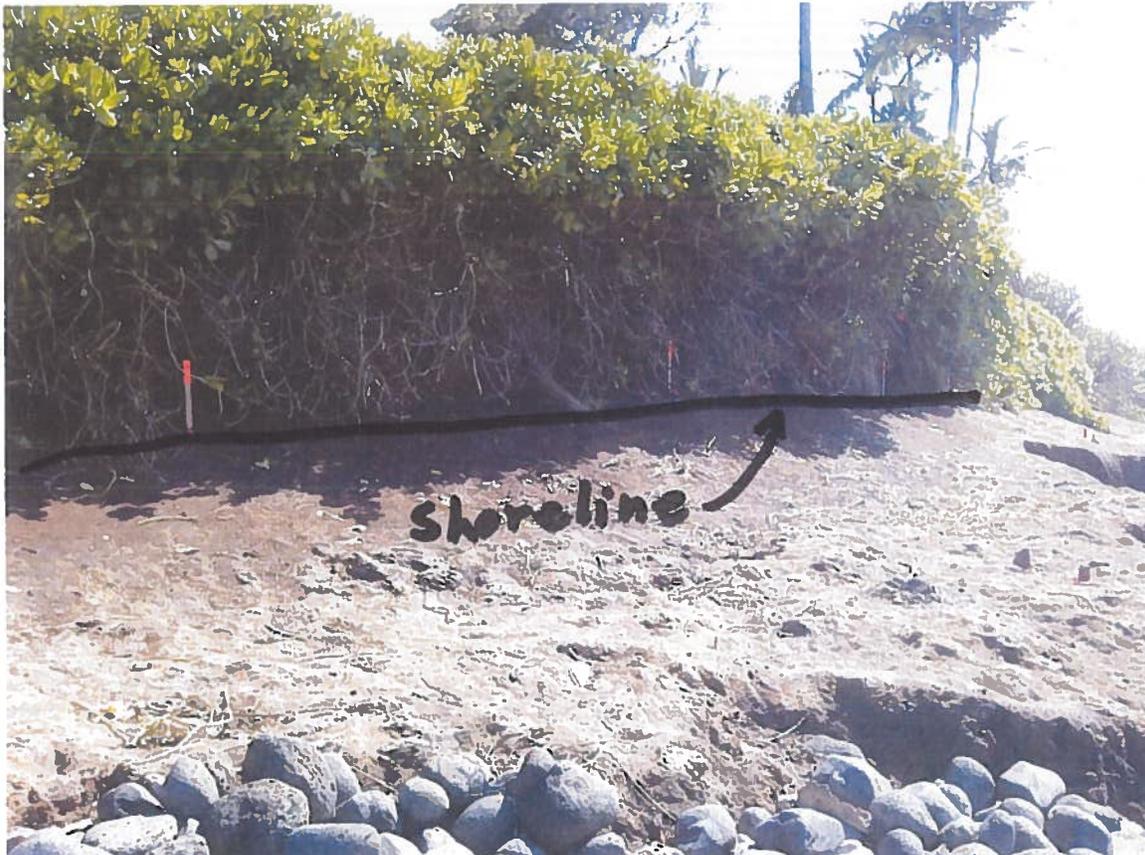
PHOTO 5: LOOKING SOUTH AT LATHS F AND LATH G . THE SHORELINE AS LOCATED ON MARCH 19, 2015 FOLLOWS THE BOTTOM OF THE EMBANKMENT.

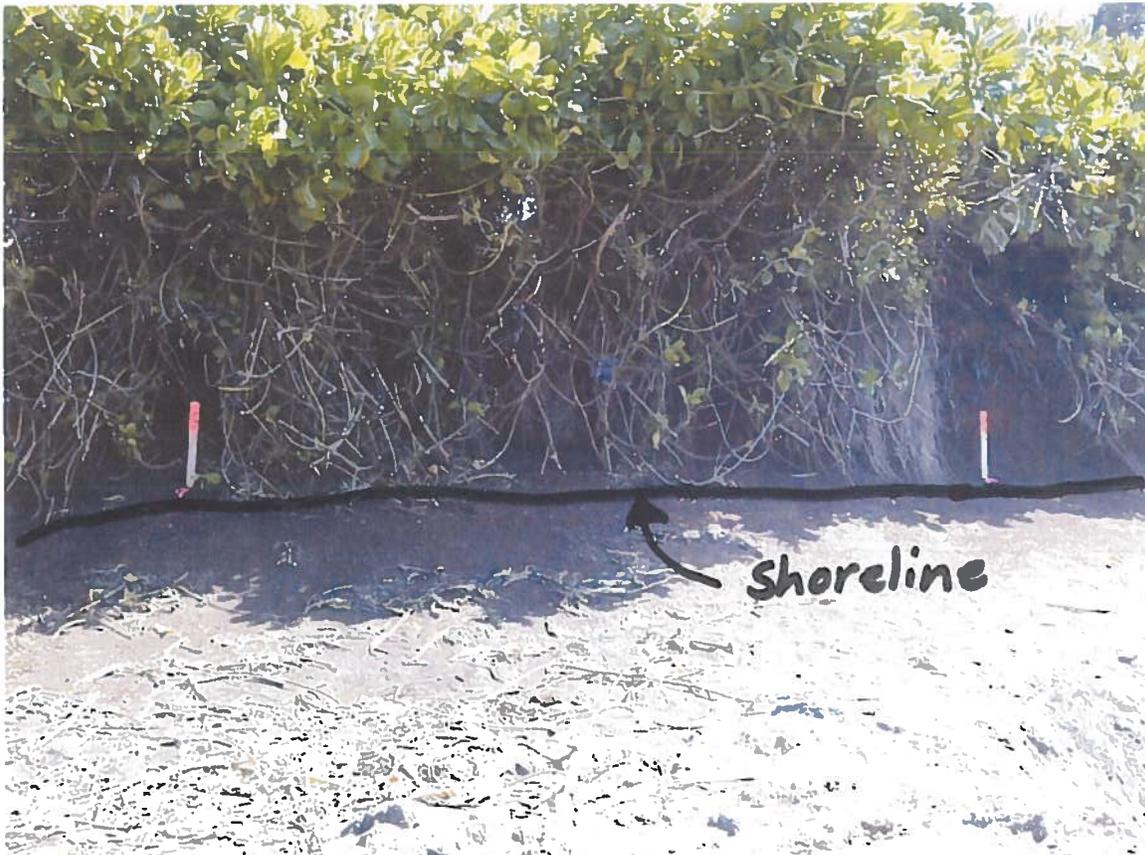
PHOTO 6: LOOKING SOUTH AT LATHS G AND LATH H . THE SHORELINE AS LOCATED ON MARCH 19, 2015 FOLLOWS THE BOTTOM OF THE EMBANKMENT.

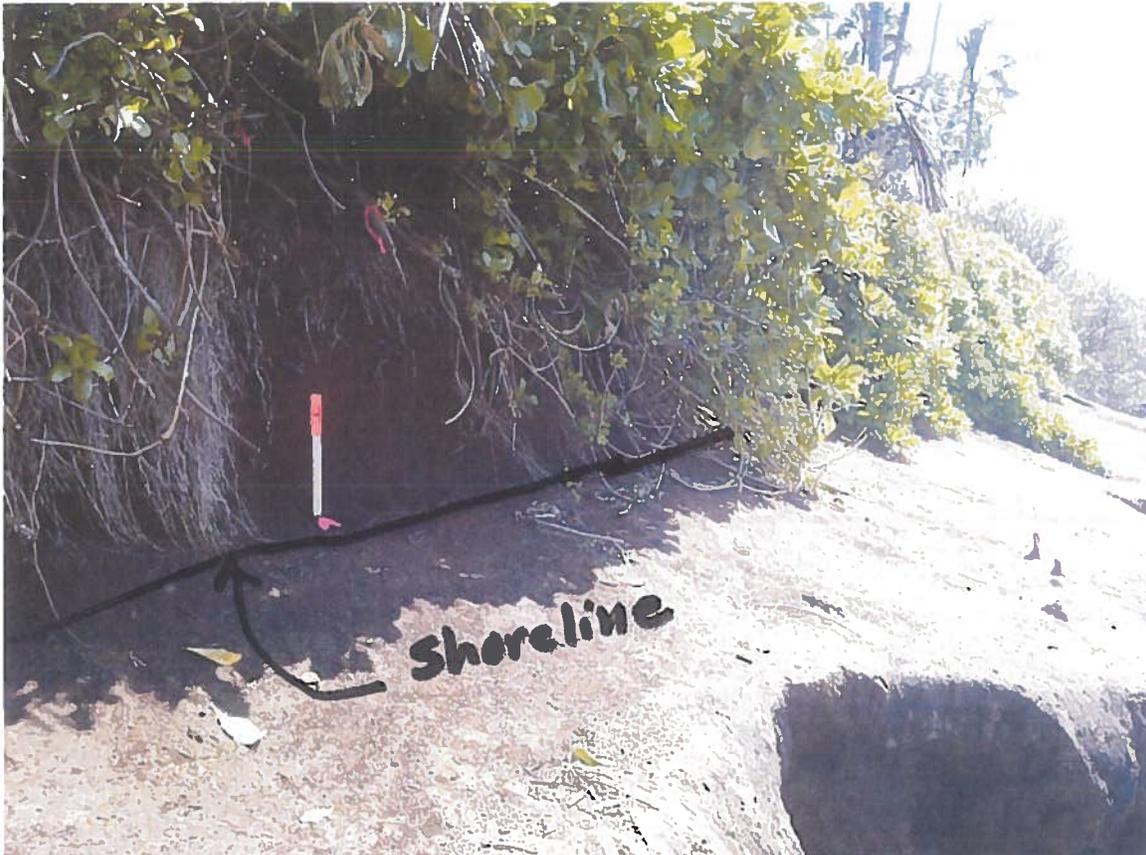
PHOTO 7: LOOKING SOUTH AT LATH H . THE OLD PIPE WITH PINK RIBBON IN RIGHT FOREGROUND IS A FORMER BOUNDARY CORNER OF LOT D-1 . THE SHORELINE AS LOCATED ON MARCH 19, 2015 FOLLOWS THE BOTTOM OF THE EMBANKMENT.

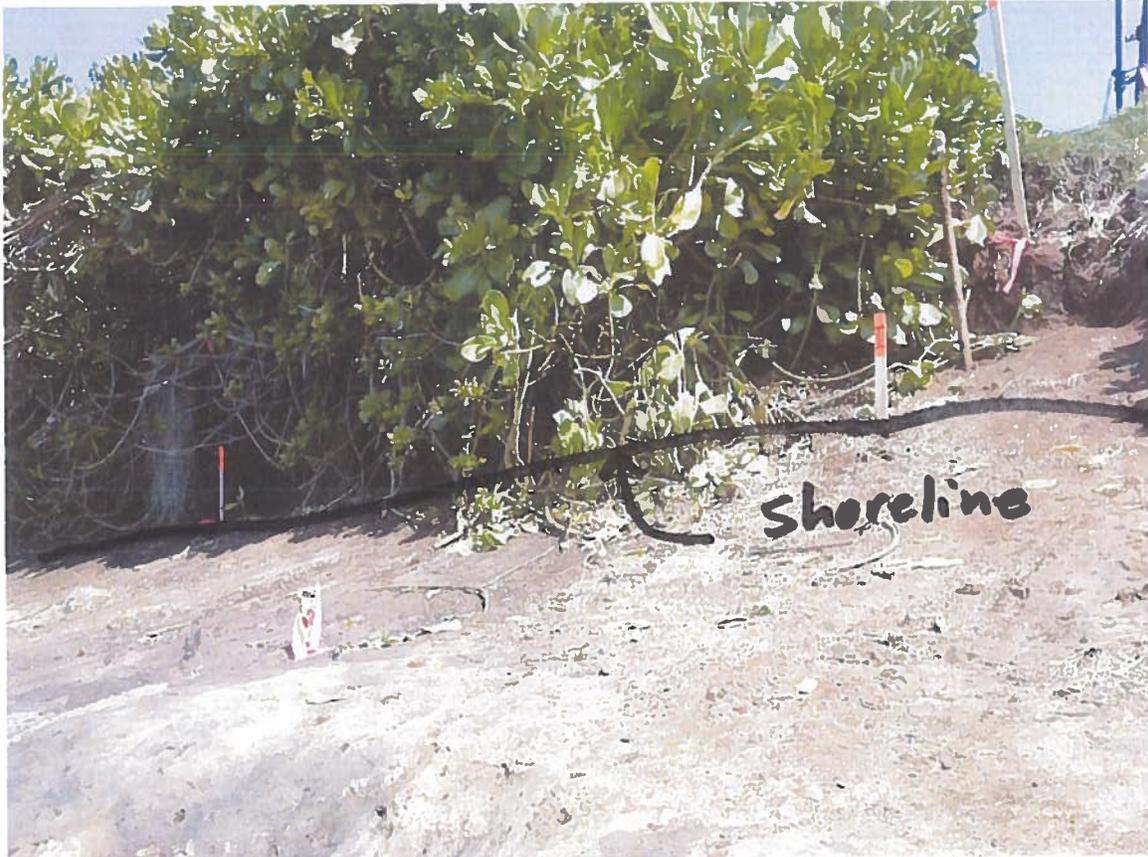
PHOTO 8: LOOKING EASTWARD AT LATH H AND LATH I . LATH I MARKS THE INTERSECTION OF THE BOTTOM OF THE EMBANKMENT WITH THE WEST BOUNDARY OF LOT D-1. A STEEL SPIKE AT THE TOP EDGE OF THE EMBANKMENT MARKS THE SEAWARD BOUNDARY CORNER OF LOT D-1 (DOC. 2008-140553)

THE SHORELINE AS LOCATED ON MARCH 19, 2015 FOLLOWS THE BOTTOM OF THE EMBANKMENT.
